# Mosaic Esterhazy K3 – North Shaft Plank Incident

Presented By:  
Daniel Ignatow, P.Eng.  
Mosaic Esterhazy K3  
Hoist Manager, K3 Capital Expansion

### Mosaic Corporate Final Incident Notification

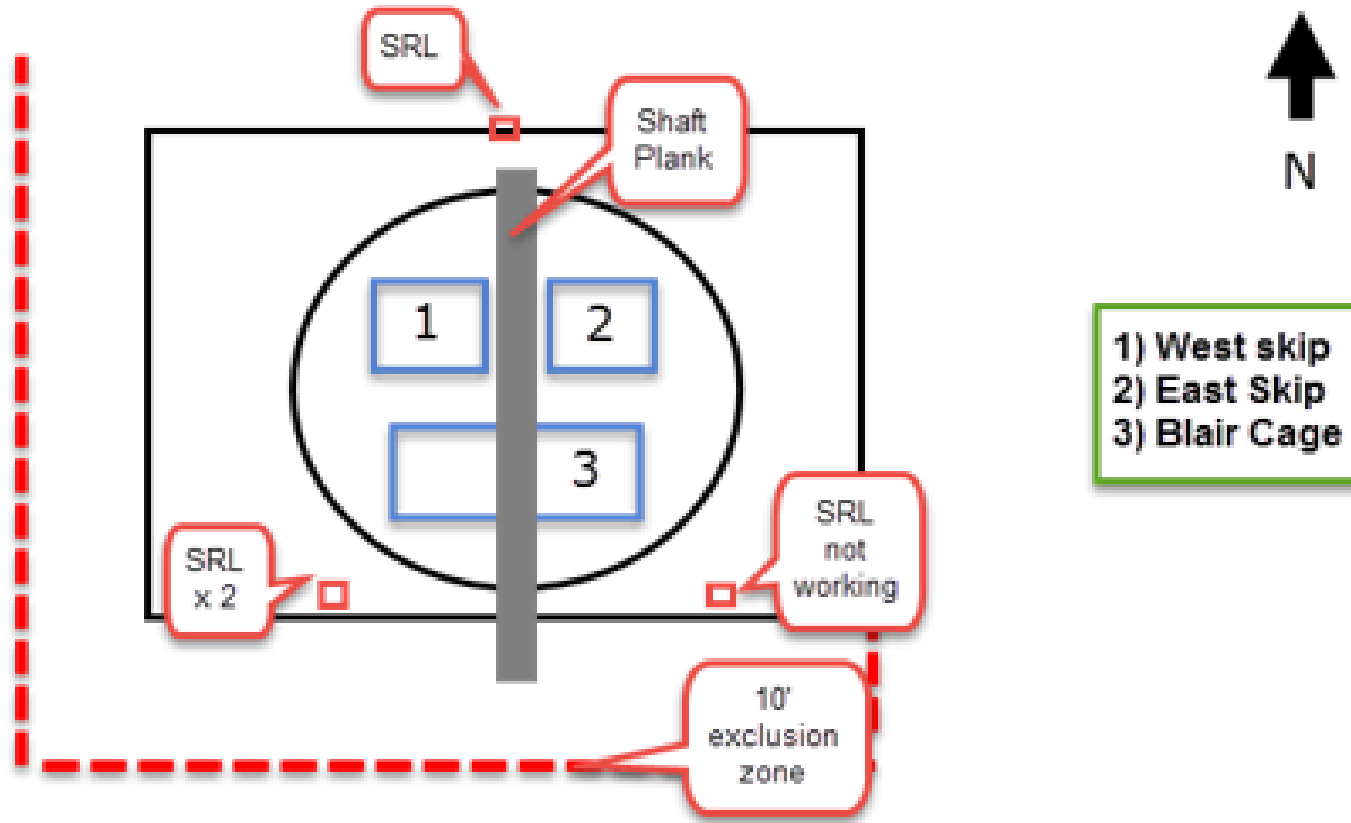
### Shaft Layout and Cage Slings Bail Design

- North Shaft crew was setting up to lower material within the Blair Cage Slings Bail
- Control room supervisor noticed that the crew had placed a shaft plank across the full diameter of the shaft
  - Notified the hoist operator to immediately shutdown the Koepe (production) hoist that was currently in automatic mode.
- During the investigation of this incident, other safety infractions were discovered through the use of the camera system.
  - Violation of Mosaic's cardinal rule ( working at heights )
  - As a result of the potential, the incident was rated as a PSI.

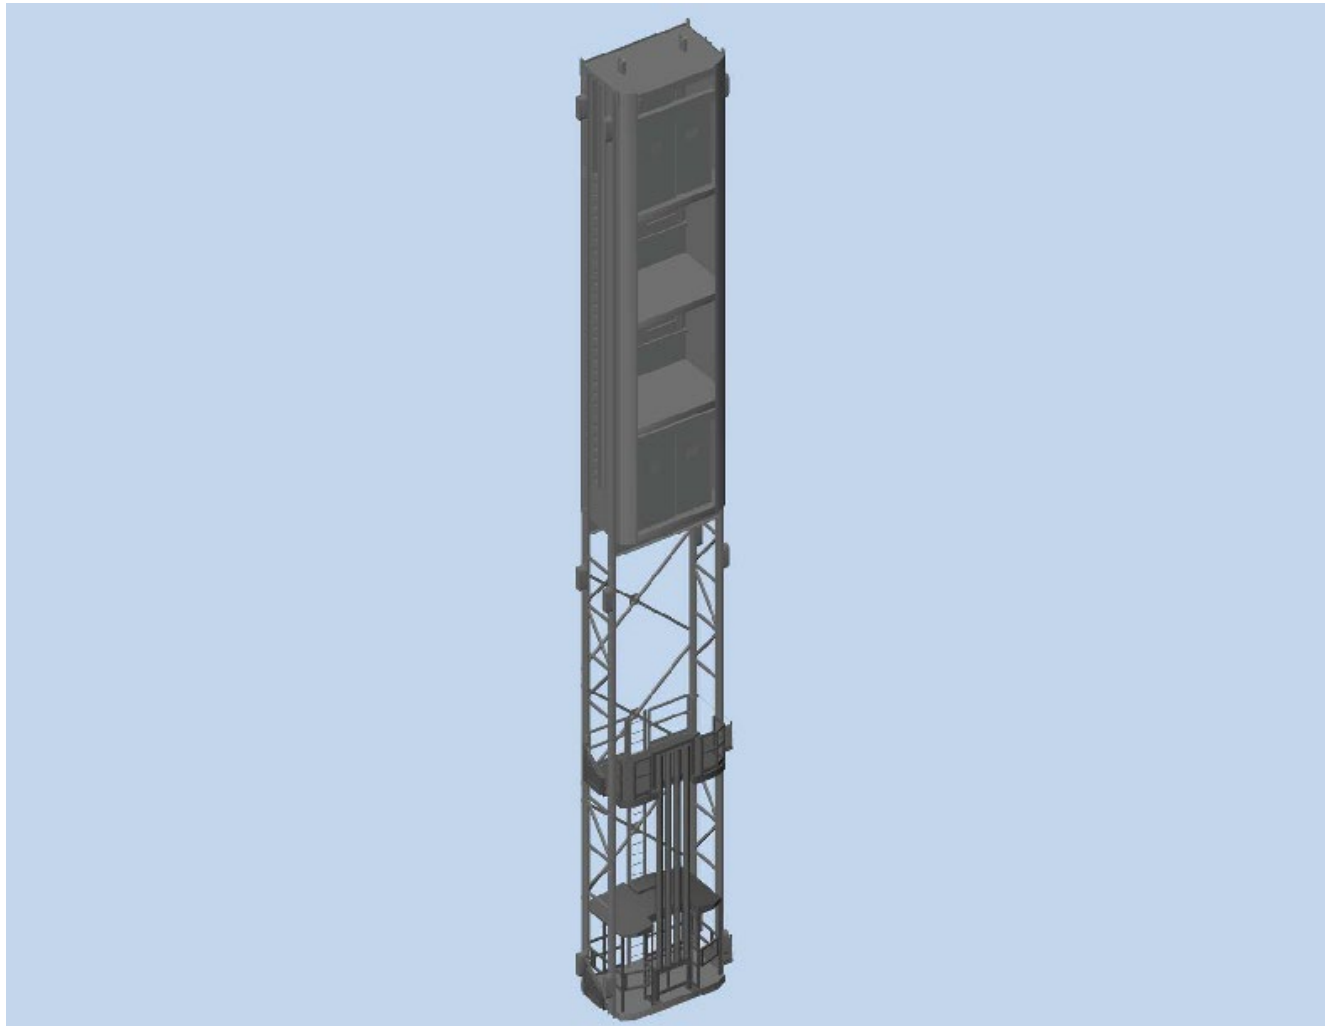
Shaft Layout and Cage Slings Bail Design (Continued)

- Lifting/ lowering plan called for a three point lift
  - Installed lifting ring- could only accommodate two slings, not three
  - Required the crew to deviate from the plan and change the lifting ring and sling arrangement
- Access to the top of the slinging bale requires use of a shaft plank
  - Crew was unaware that the Koepe (production) hoist was in automatic
  - Crew performed separate FLRA
  - Unaware of the risk, until dust collector was heard starting operation

- Formal Review Conducted
  - Lowering SOP
  - Working in Shaft SOP
- Group FLRA's Mandatory
- Implemented Non-Working Supervisor
- Access to Lowering Information
- Engineering Controls
  - Electronic Gate Lock Installed with Flashing Light
