SMA SAFETY SUMMIT 2020

K+S POTASH CANADA - BETHUNE MINE

Medium Voltage – Electrical/Loto Incident
Gene Cochrane

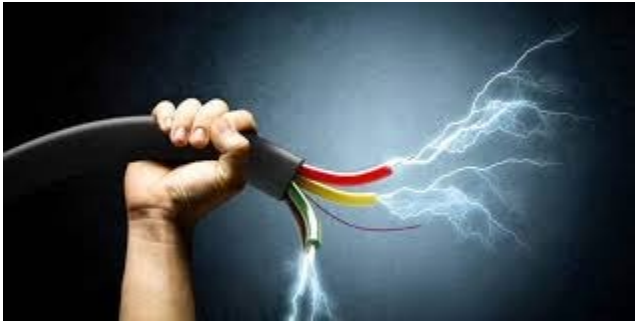
- **Incident occurred on August 13, 2019.**
 - Task...re-route cables for makeup air unit to allow new construction
 - LOTO placed on **wrong** MakeUp Air Unit, LOTO steps **not followed** through to local disconnect, verification process **not followed** at local disconnect resulted in electrician receiving 347 volt shock

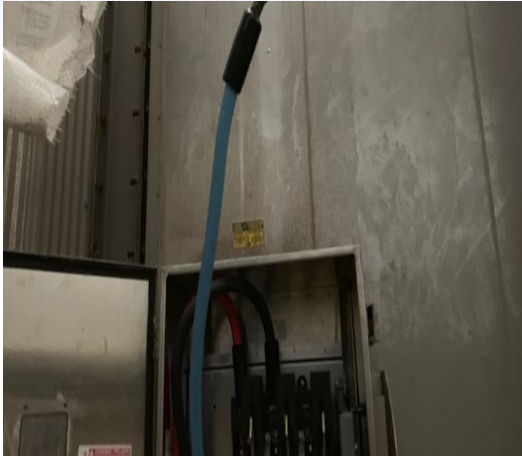
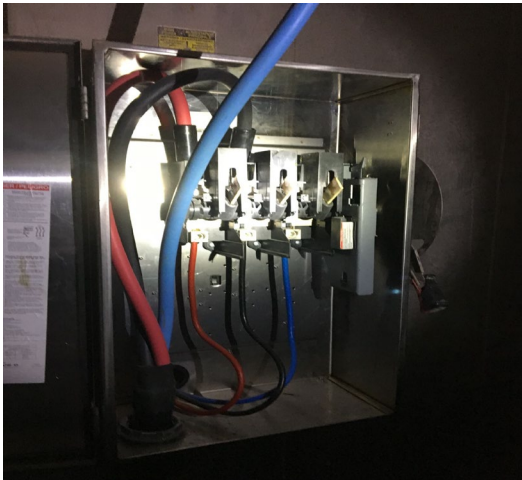
- **Aug 9 – Discuss cable re-route plan**
- **Aug 12 – Prepared LOTO, no SWP provided**
- **Aug 13 – SWP & LOTO reviewed for 2 isolations**
 - Went to both MCC disconnects
 - Contacted Operations
 - Opened the disconnect for each device...confirming loss of power on the PCS.
 - LOTO confirmed at MCC location.
- **LOTO complete on 2951-FCL-902 vs 2970-FCL-902**

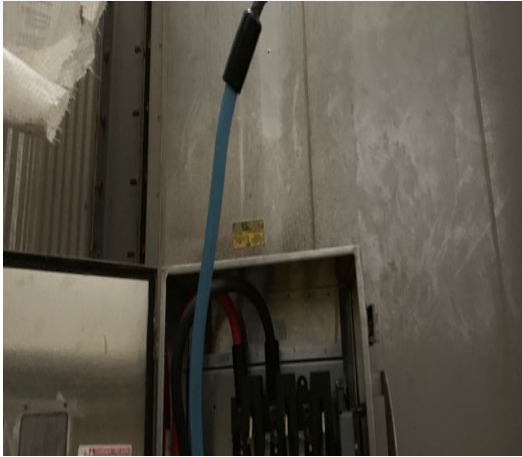
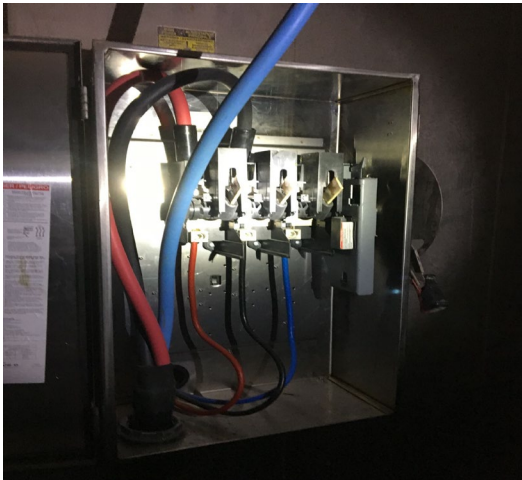
- **Continued activity at work face (i.e. local disconnect) required:**
 - Electrician removed 'C' phase lead...no issue
 - Busy area...requested to disperse while an overhead lift was completed
 - Lift complete...electrician resumed work
 - Tried 'B' phase wire but still tight
 - Used allen wrench and **received a shock**
 - Stopped and checked LOTO
 - Immediate investigation and medical assessment of worker

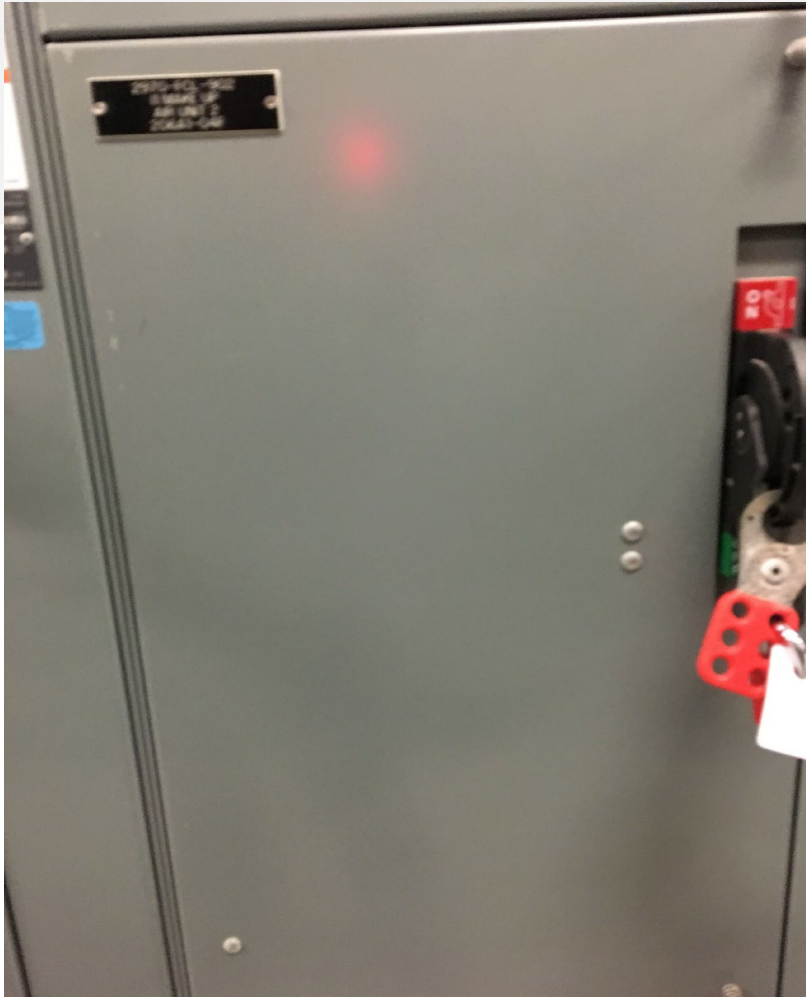
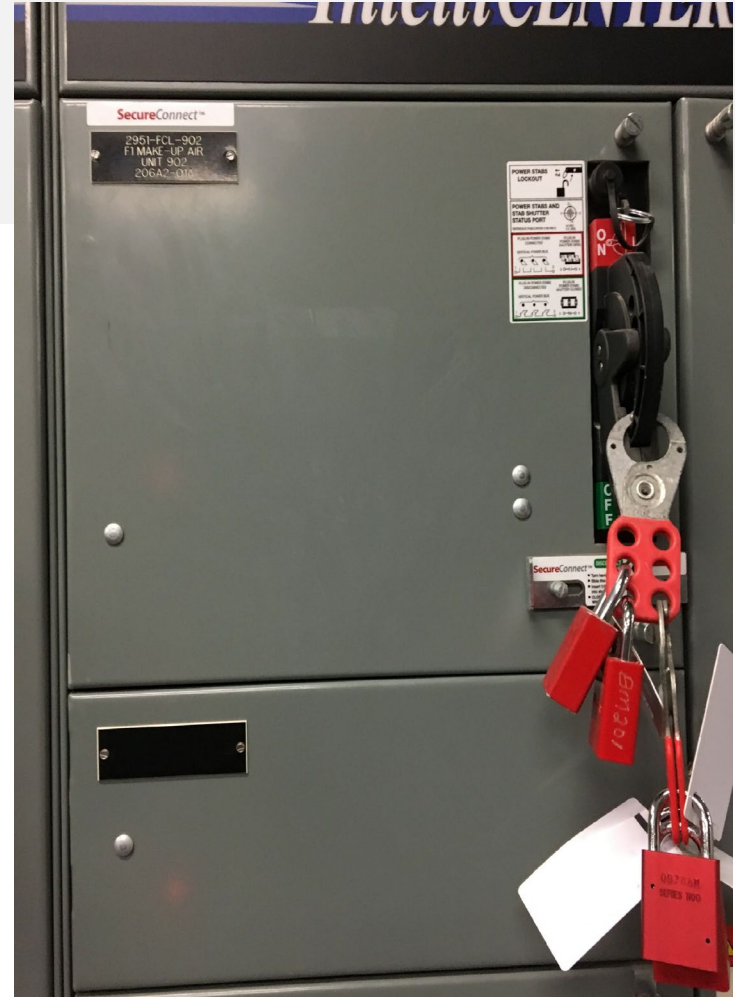
ROOT CAUSE ANALYSIS(2)

ROOT CAUSE: LOTO process not followed to ensure zero energy state!

- **Contributing factors...processes not followed:**
 - Pre-walkdown to verify scope of work prior to requesting work permit
 - Safe work permitting...requestor to fill out SWP which kicks off successive steps
- **Verification step...walkdown of lock out**
 - Review of documentation at work front
 - Includes testing to ensure zero energy by competent personnel at all areas necessary.(MCC and/or workfront)
- **Special note...numbering convention (similarities)**
 - Example...2970 FCL 902 ✘ vs 2951 FCL 902 ✔

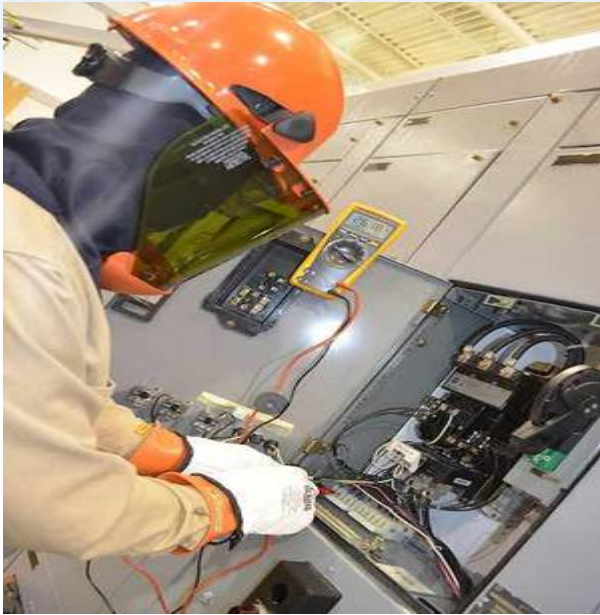
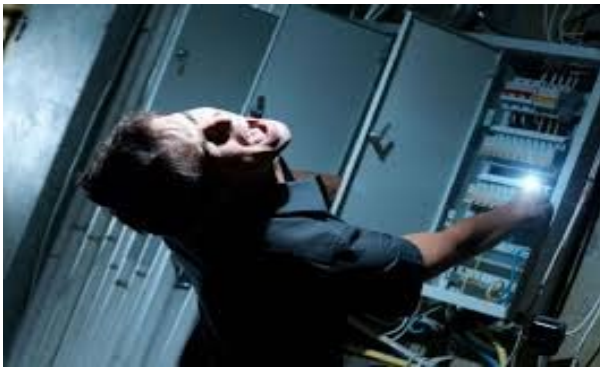
- ✘ No pre-job planning walkdown
- ✘ SWP not initiated as first step (verbal request initially, then SWP filled out later)

- **LOTO steps not followed:**

- ✘ No confirmation of zero energy at local disconnect
- ✘ No involvement by a competent electrician
- ✘ No field tag verification of field equipment with paperwork (i.e. drawings w SWP)
