Cable Strike Awareness & Elimination

Mosaic Potash - Esterhazy K1 Mine

PBU Cable Strike Team

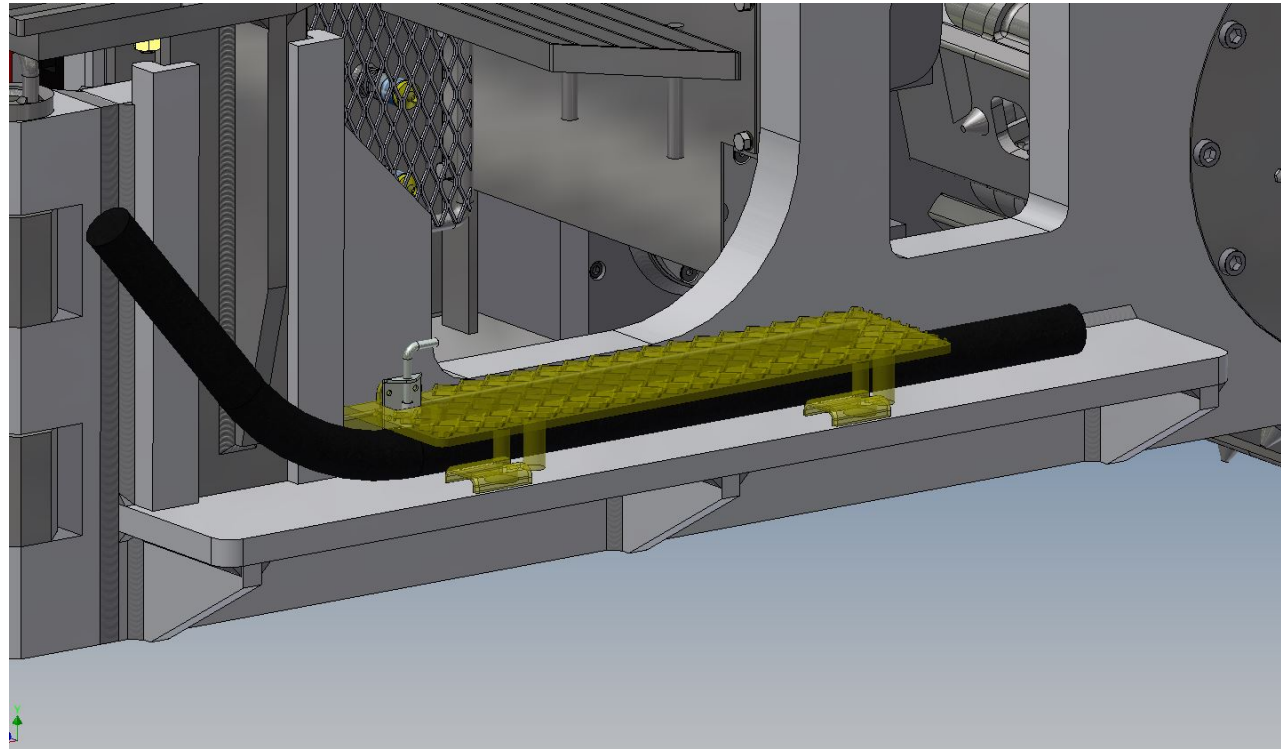
- Two rotor cable step

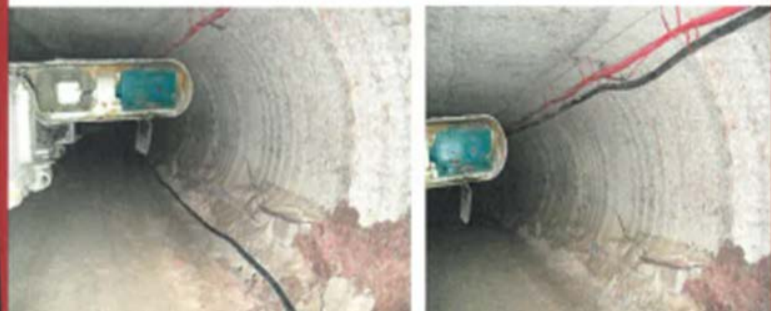
01008 Car and Loader Setup for BT Cutting

The miner cable was on the floor directly behind the miner. When miner would begin cutting, the cable would have been covered in muck and in the position to be struck by the loader.

Slack was pulled up and cable hung.

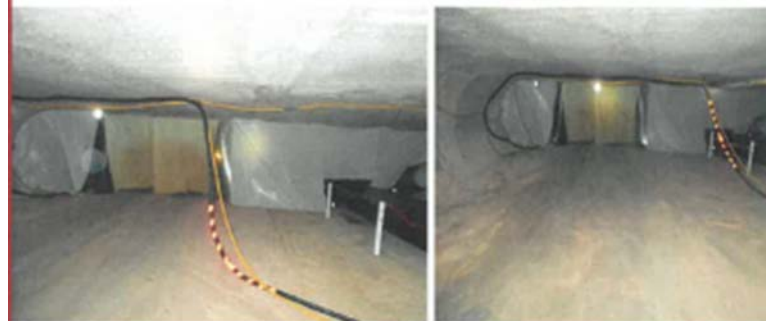
Potential 4160 Cable Strike

An existing 4160 cable was at the entrance of 1002's room.

The hung cable was out of sight when proceeding through the door (due to the strip door flaps) and would potentially come in contact with the vehicle if one entered through the door too far to the left. The cable was de-energized and secured to the back an additional 8 feet to eliminate this hazard.
