Conveyor Take-Up Weight Failure Vanscoy Potash Operations

SMA Mine Safety Summit 2018
Presenter: Marc Carignan, Inspector

March 1, 2018

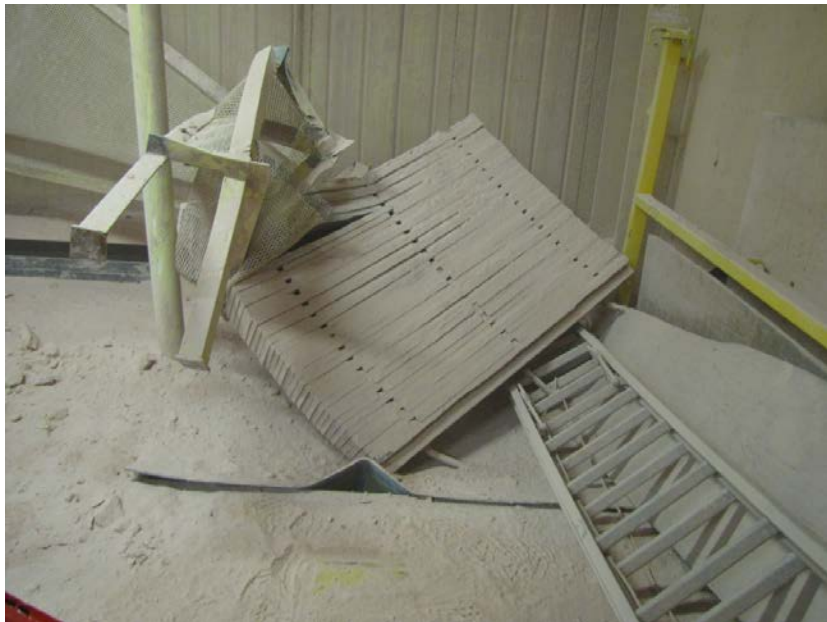
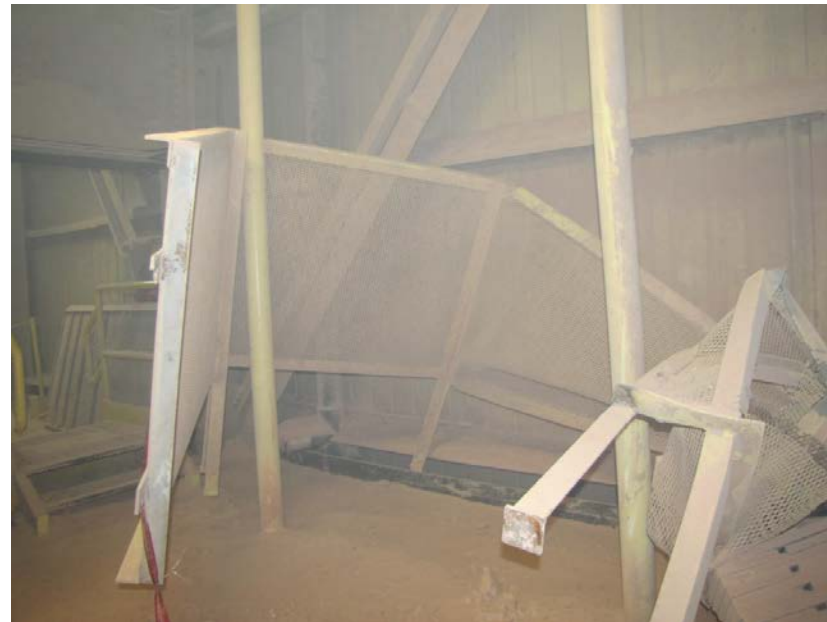
- 1pm October 30, 2017
- Loadout belt SK-14020
- No witnesses to the actual event
- Weight: ~8500 lbs
- Fall height: 8 – 20 ft

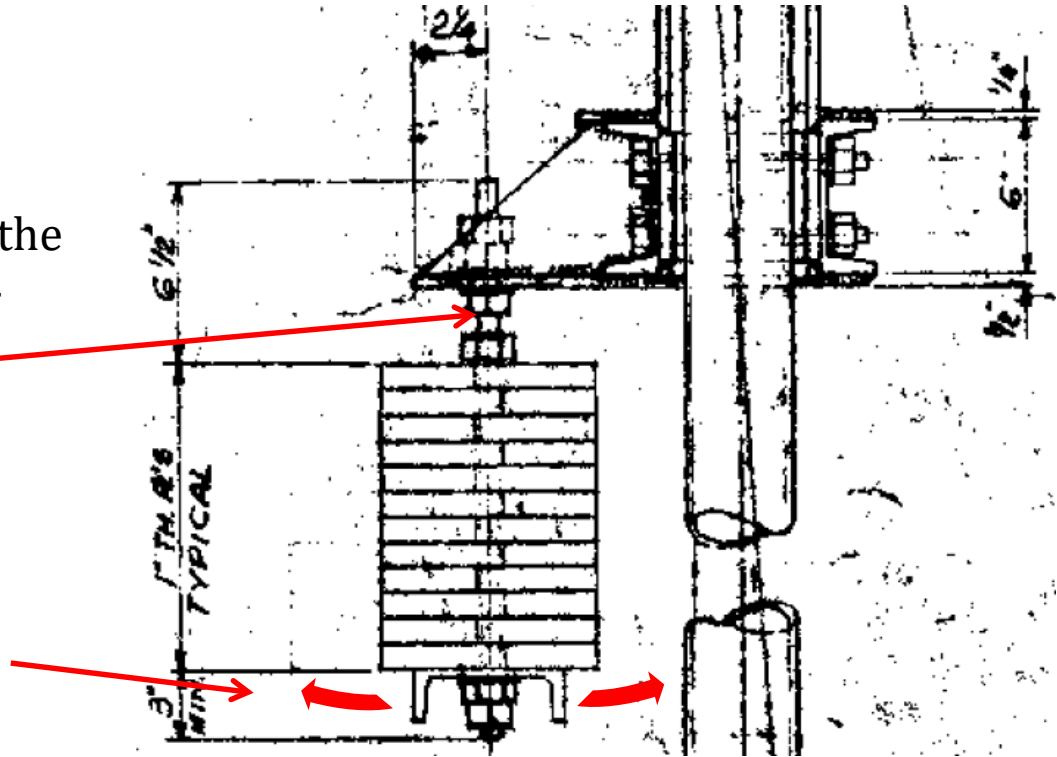
Failure Mechanism

- Fatigue cracks developed in the thread roots of 2 of the 3 all-thread support rods at this location
- Vibration/Swaying of the assembly when the belt is in operation
