SASKATCHEWAN MINING ASSOCIATION

October 18, 2018

OBED MOUNTAIN MINE 2013 MINE WASTEWATER RELEASE

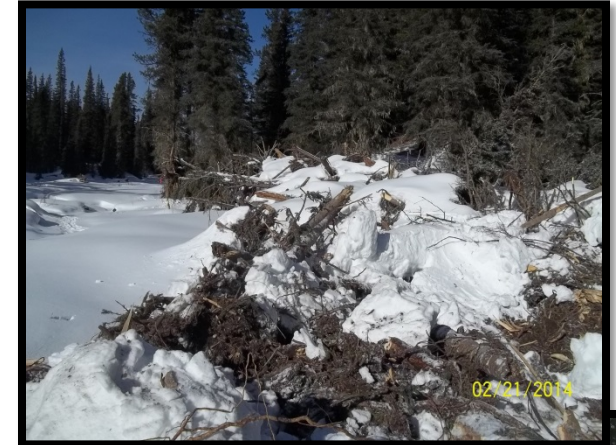
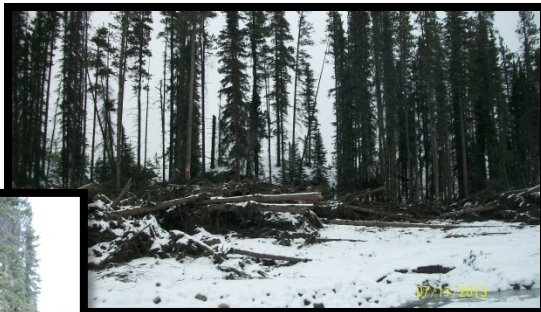
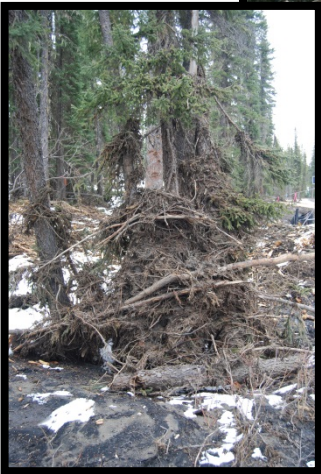
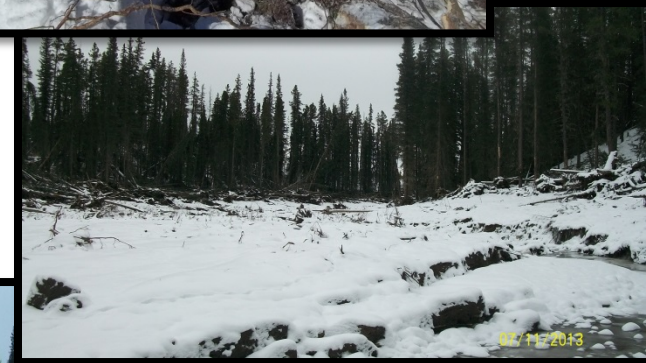
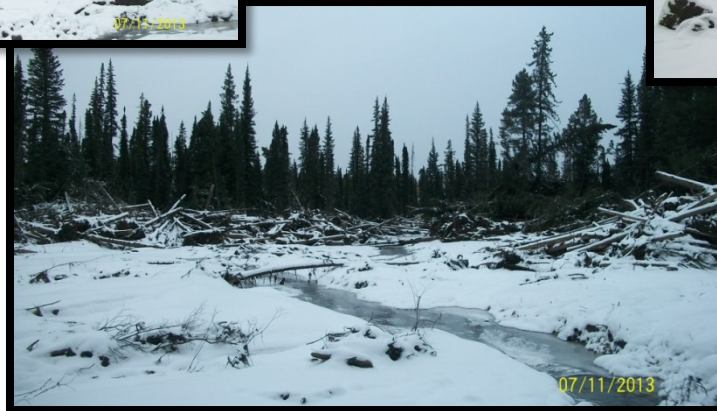
Downed timber and soil erosion

- Timber was uprooted and deposited in windrows beside the flow path
- Large accumulations in some areas
- Upper soil horizons eroded by the flood waters in some areas

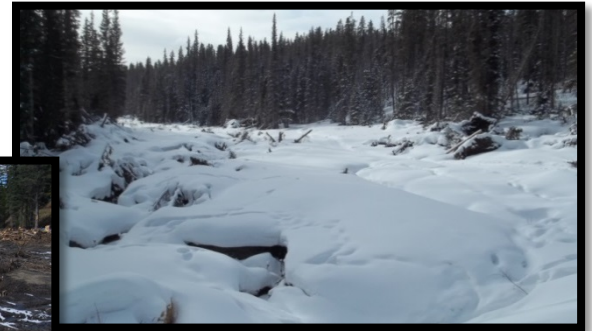
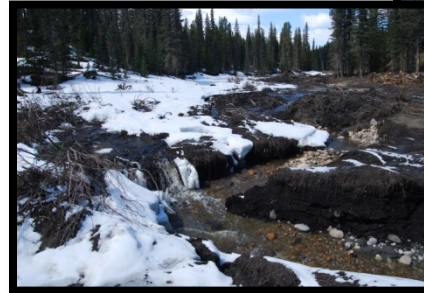
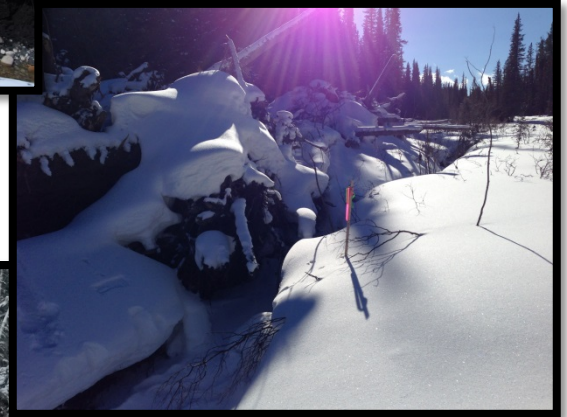
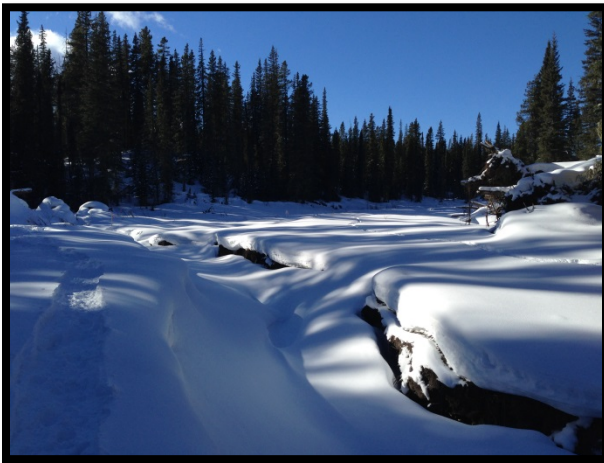
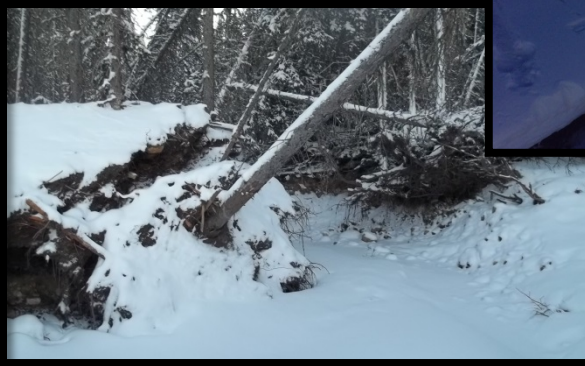
Creek bed and banks

- Bank undercutting
- Channel widening
- Loss of channel
- Beaver dams damaged

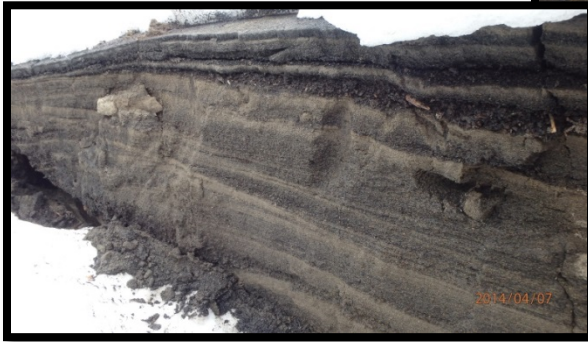
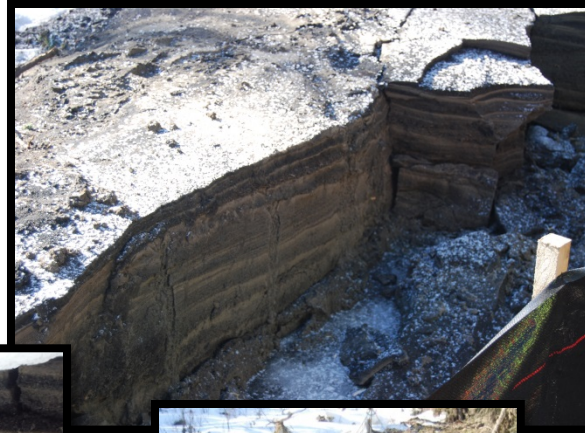
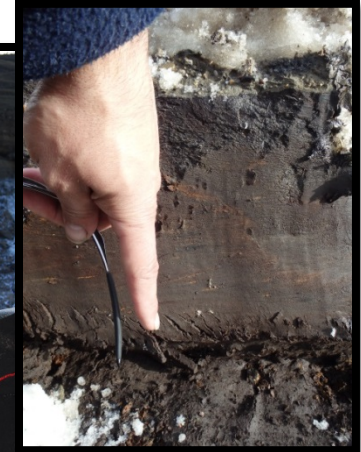
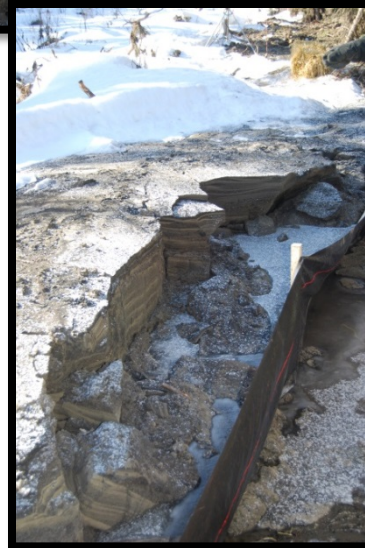
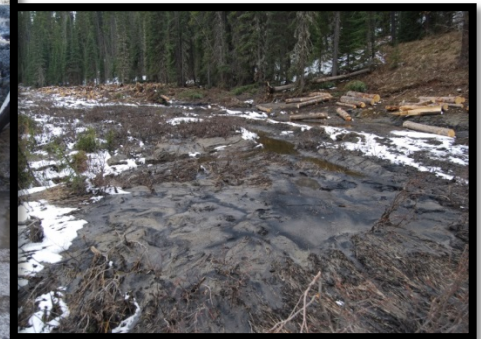
Solids deposition

- Deposits were a mix of released material and material eroded along the release path

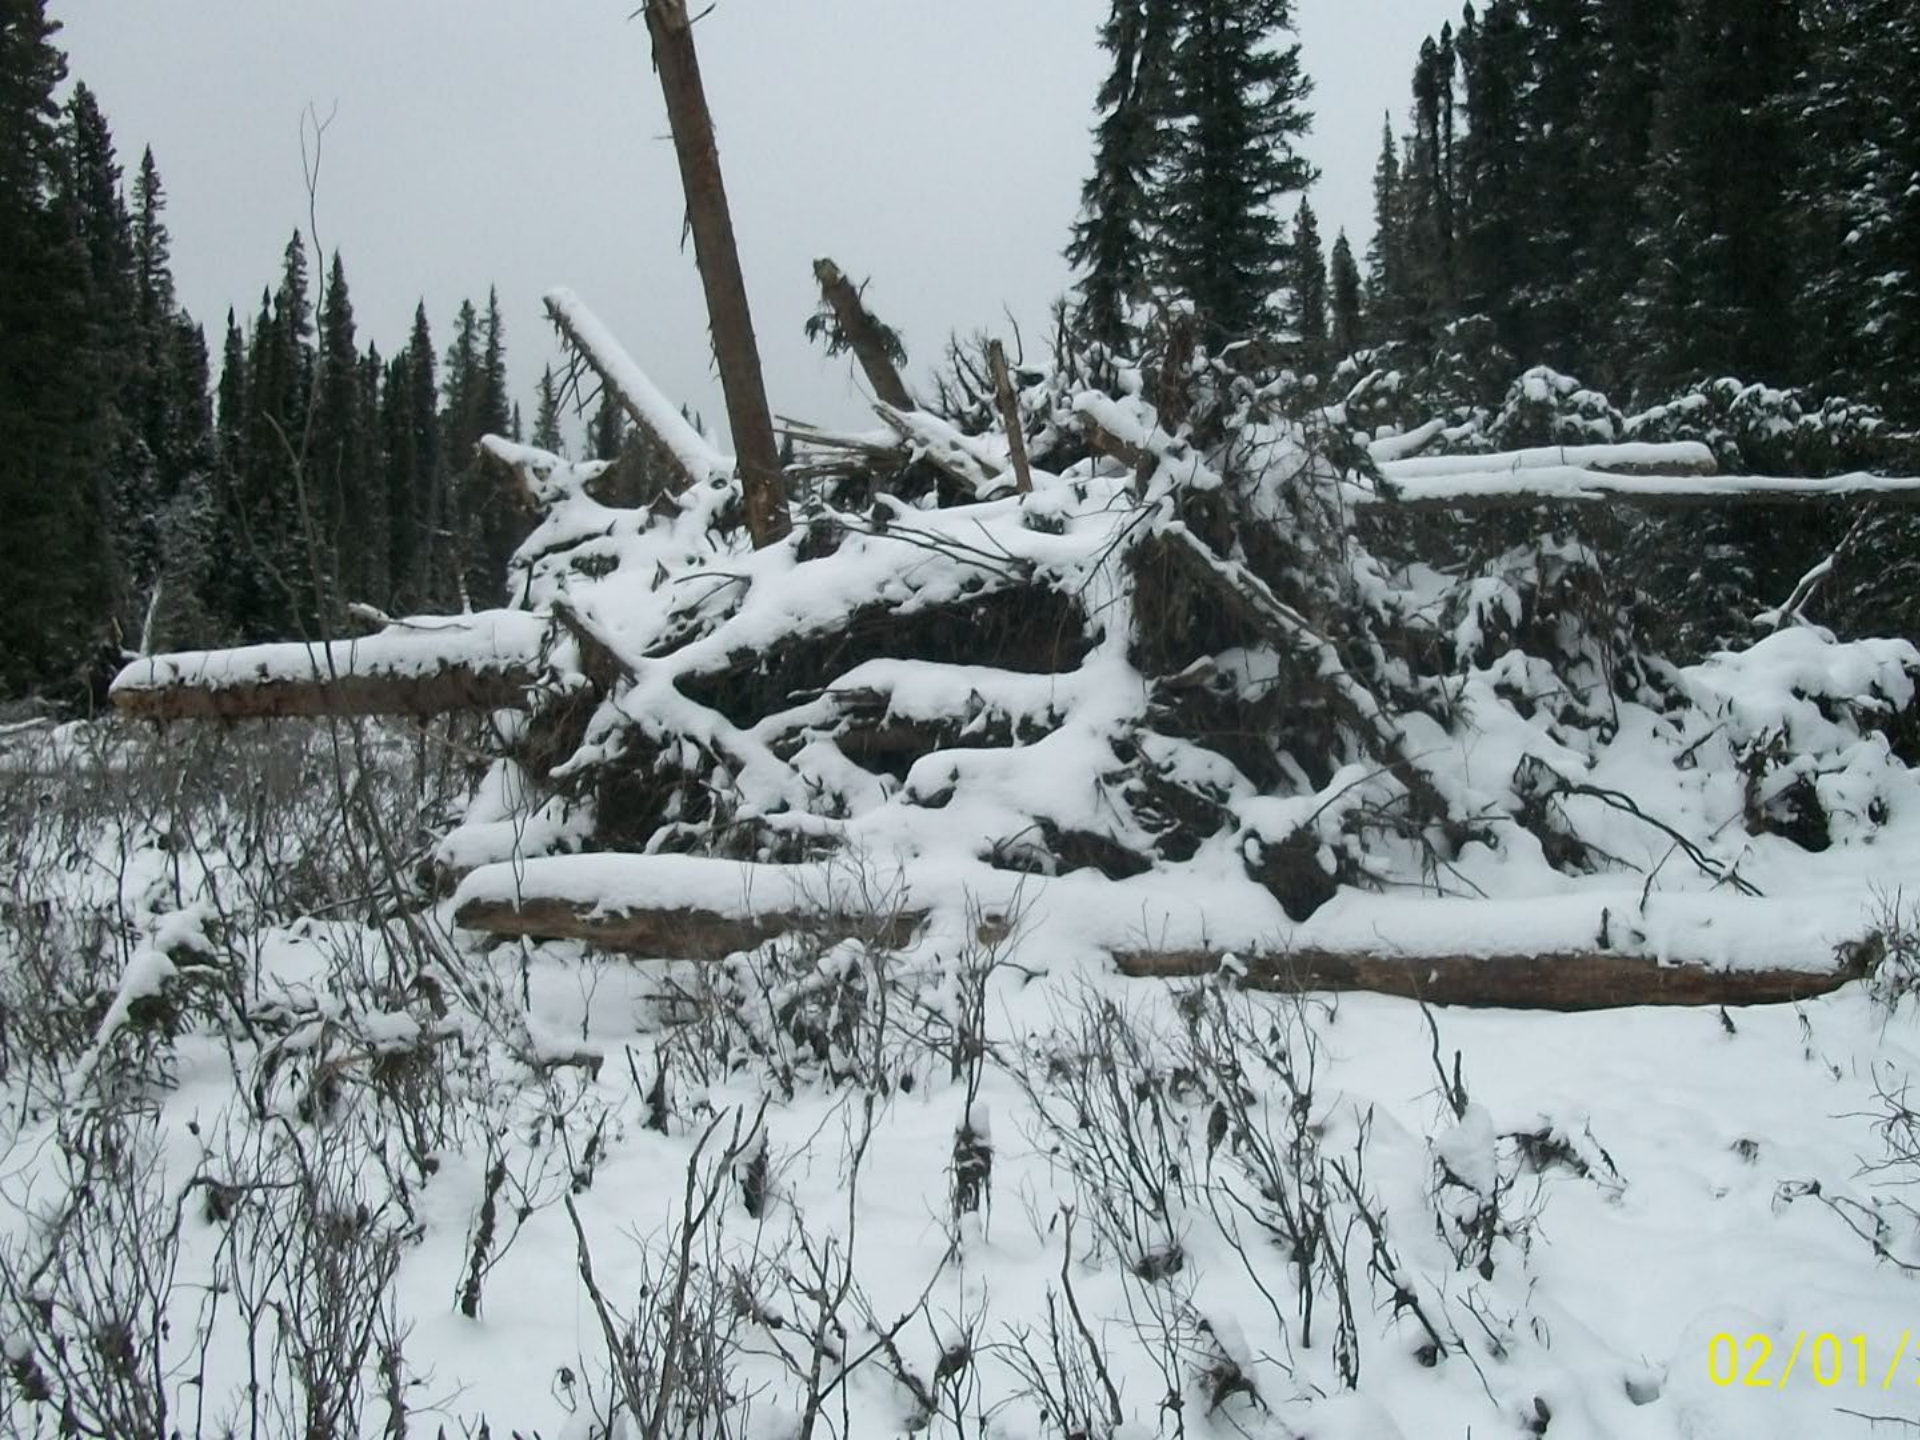
Major deposits located where the water slowed and pooled:

- DX road crossing
- Upper and lower blowout areas

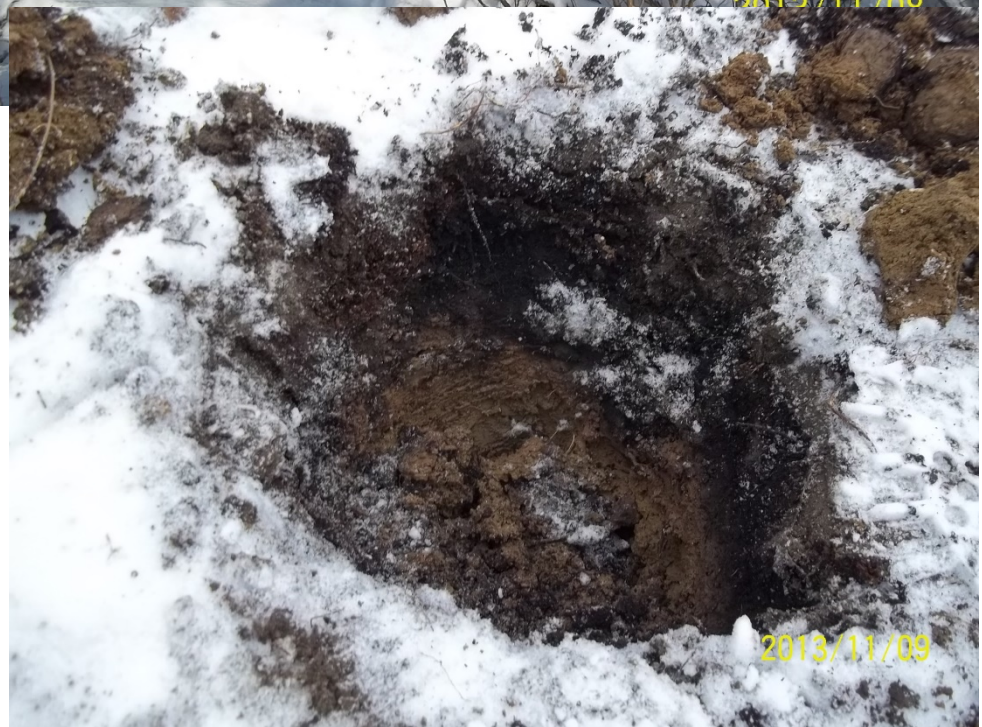
INITIAL ASSESSMENT NOVEMBER 2013

- SUBSTANTIAL EROSION OF STREAM BANK MATERIALS
- DISTURBANCE TO MATURE BLACK SPRUCE VEGETATION COMMUNITY
- DEPOSITION OF RELEASED MATERIAL
