Dozer in the Water January 21, 2017 Estevan Mine

# **January 21, 2017**

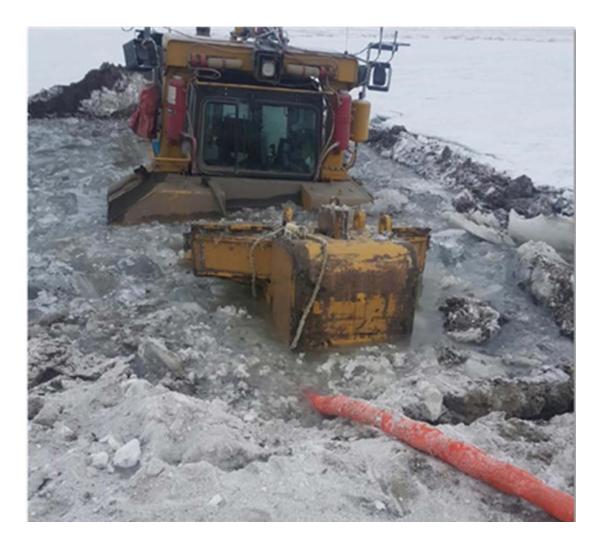
At approx.12:10 am Dozer pushed 1.5 times past the lines shown on GPS screen.

The Dozer came to a stop on a frozen pocket of water, the dozer operator was not aware that he had stopped on the ice over the water.

When the dozer operator proceeded to backup off the body of water the dozer broke through the ice landing flat on both tracks in approx. 2 meters of water. The operator was able to exit the dozer onto land.

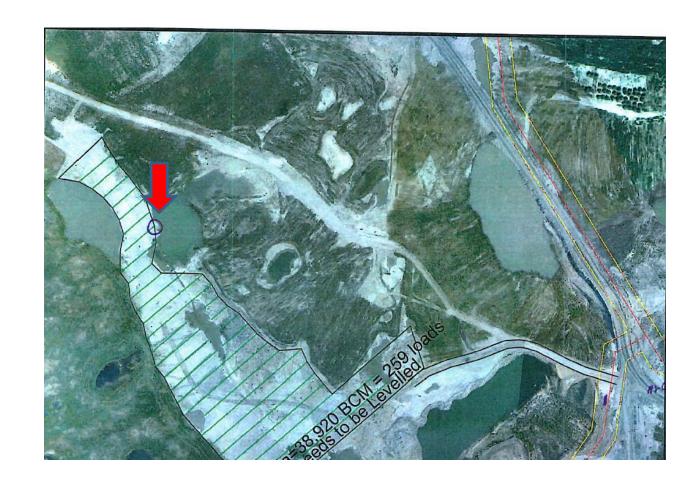
#### **Causal Factor 1: Water Hazard**

- Water hazards not identified on recent map
- Lack of senior MGMT approval for maps
- Lack of quality control on mine plan development

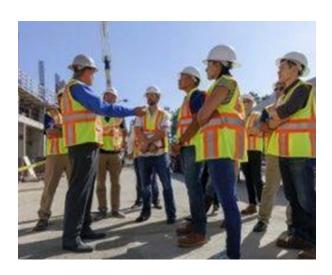
## **Causal Factor 2: Communication Needs Improvement**

- Inadequate work instruction
- Failure to review work plan
- Operator assumed instruction
