Portable Pressure Washer Failure

Potential Serious Injury or Fatality Incident

Todd McCorriston, Mill Manager

February 27, 2020

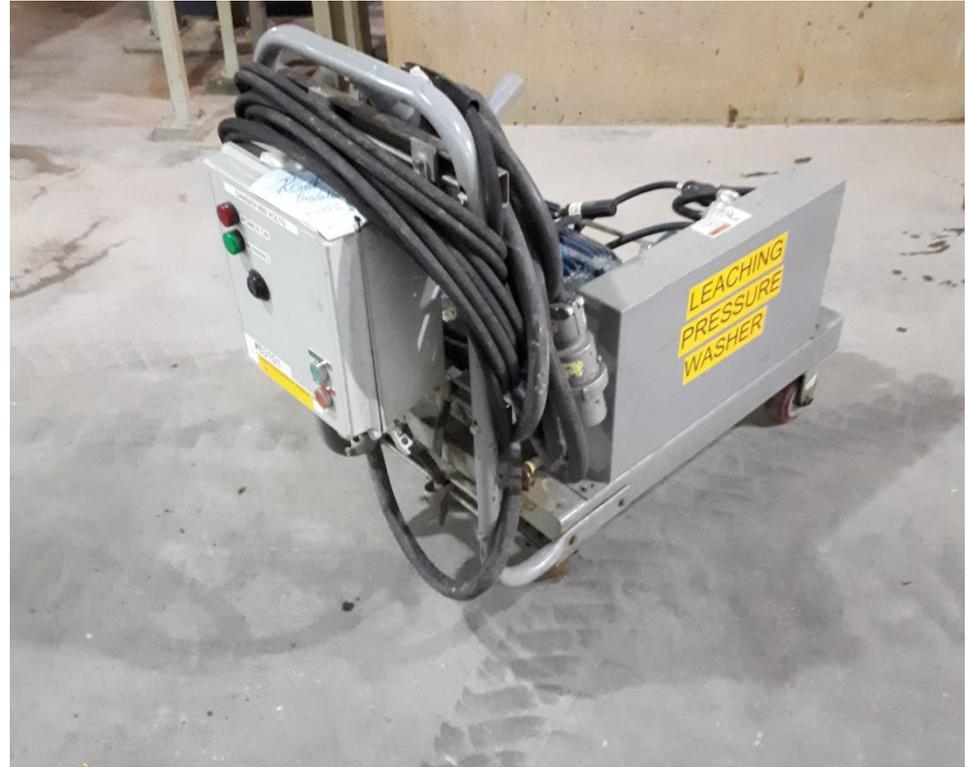
Solvent Extraction Building

- **This incident happened during a summer Shutdown in 2019**
- **It occurred in one of our Solvent Extraction Plants**
- **Occurred during a routine cleaning exercise**

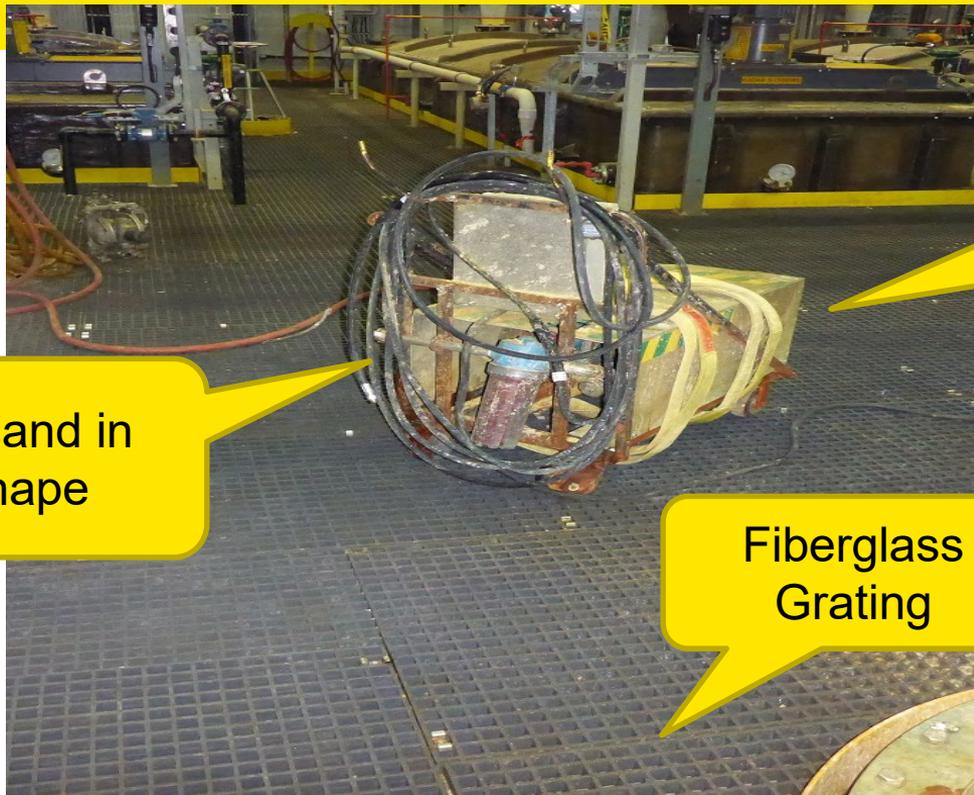
Portable Pressure
Washer
600 Volt

Well used and in
rough shape

Fiberglass
Grating

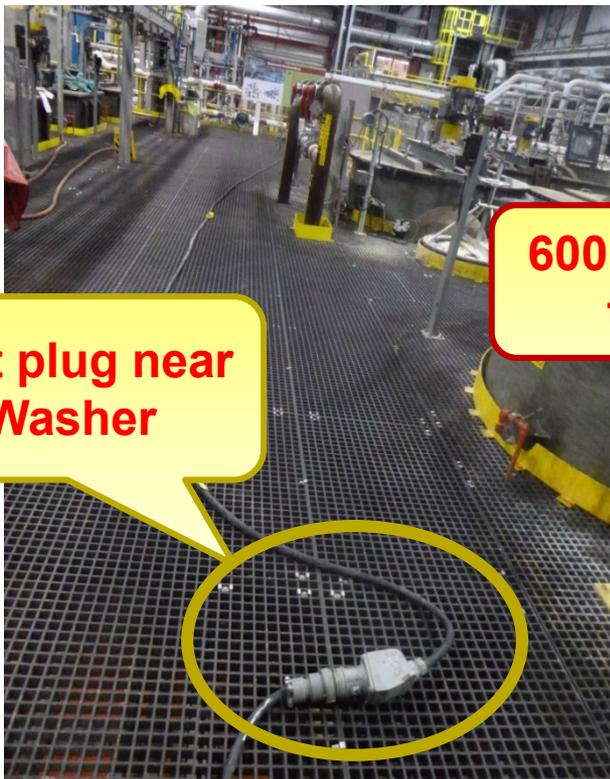
600 Volt plug near
the Washer

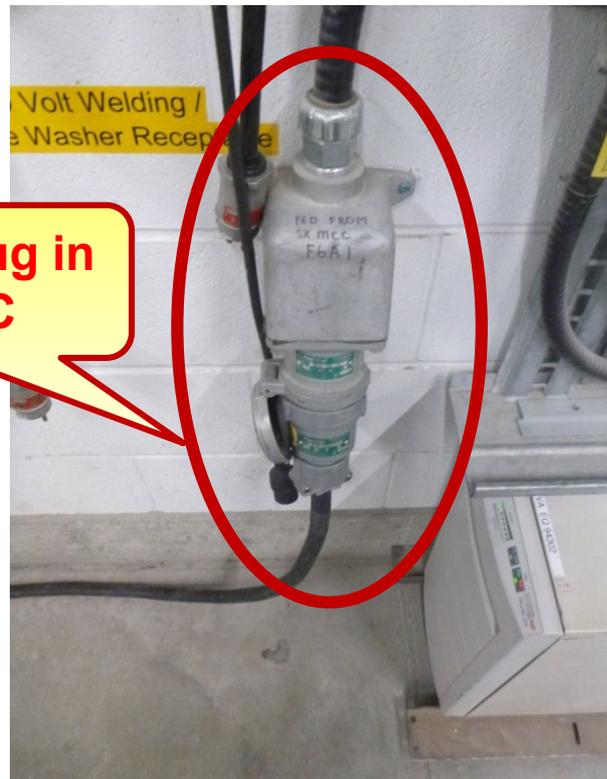
600 Volt plug in
the MCC

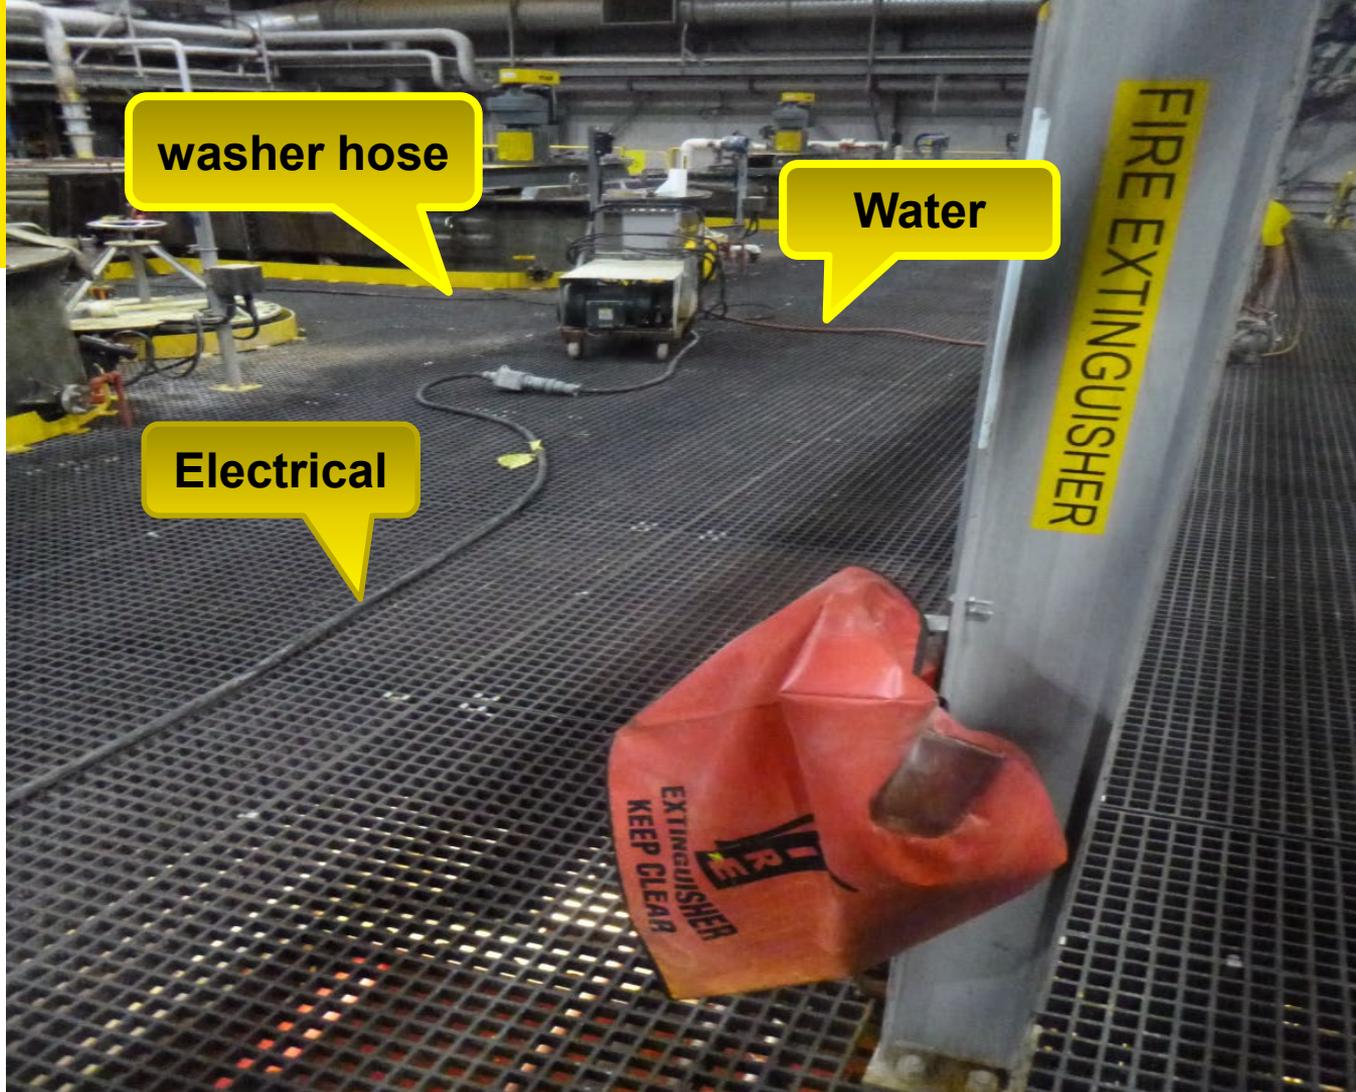
washer hose

Water

Electrical

FIRE EXTINGUISHER

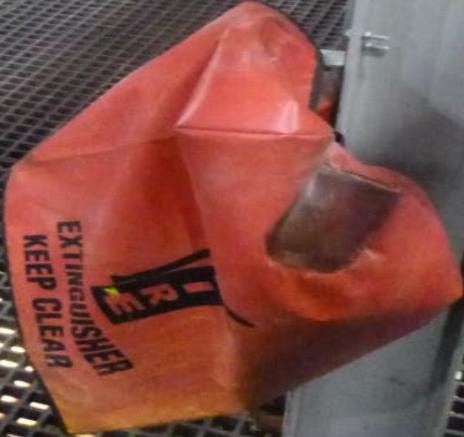
The Fire

- The washer was not running electrically and hadn't been started yet
- Operator heard a static noise like snapping
- Discovered the pressure washer water hose was on fire
- It was a small localized flame about 2 inches high

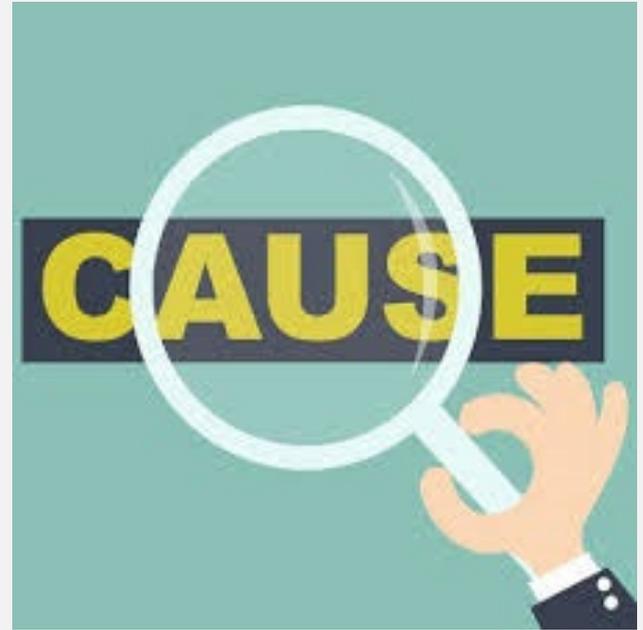
The investigation

- The pressure washer water hose has an internal steel braid for pressure and strength
- Through rough service and wear and tear the rubber covering can be come damaged
- In this incident the rubber was gouged and deep enough to expose the steel braiding

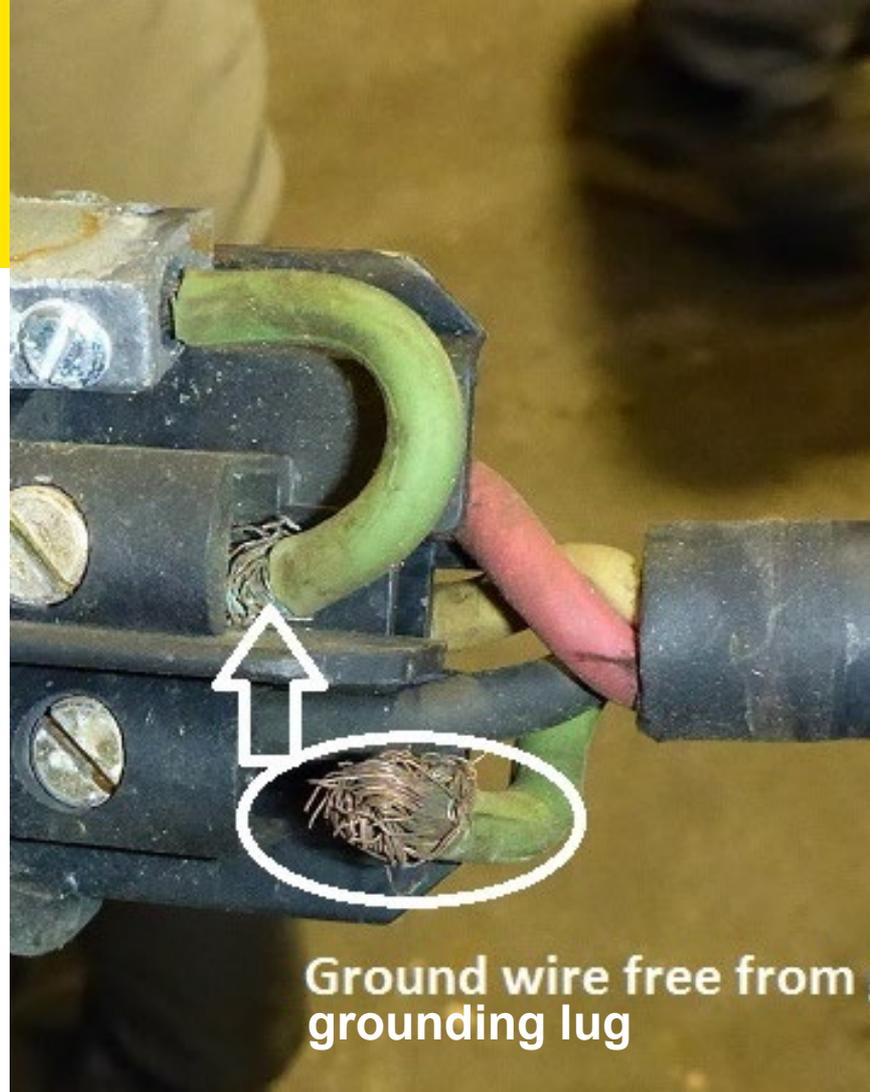
- The green ground wire had come loose in the welding plug cable on the pressure washer
- This wire moved over to one of the “powered” lugs and made connection
- The ground wire was now powered or “hot” and carrying voltage to the pressure washer frame, housing, guard, etc.

Ground wire free from grounding lug

- **Immediately inspect all other high voltage portable equipment for a similar condition**
- **Examined current preventative maintenance plans for this types of equipment – found to be deficient**
- **Initiate a quarterly preventative maintenance plan that not only examines the physical condition but also check the wire condition and continuity**
- **Record or log the inspections in the maintenance management system to track the history of inspections and repairs**

- Ground sensing devices could be used in the equipment, such as a Startco ground fault trip device.
- Other devices can be installed in the motor control center such as ground fault breakers or GFI's

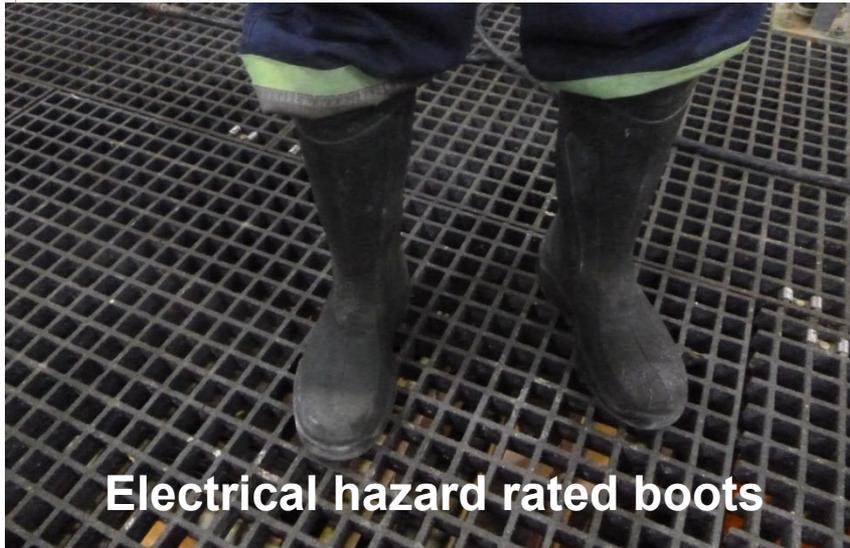
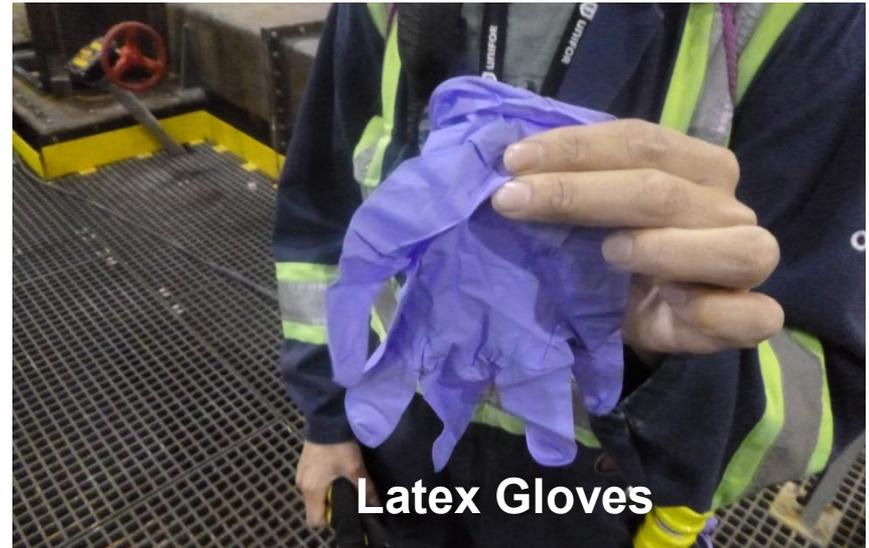
The investigation

- The operator was wearing Non-conductive electrical hazard rated rubber boots
- Latex gloves were also worn but are not electrically rated and would give little or no protection to electrical shock

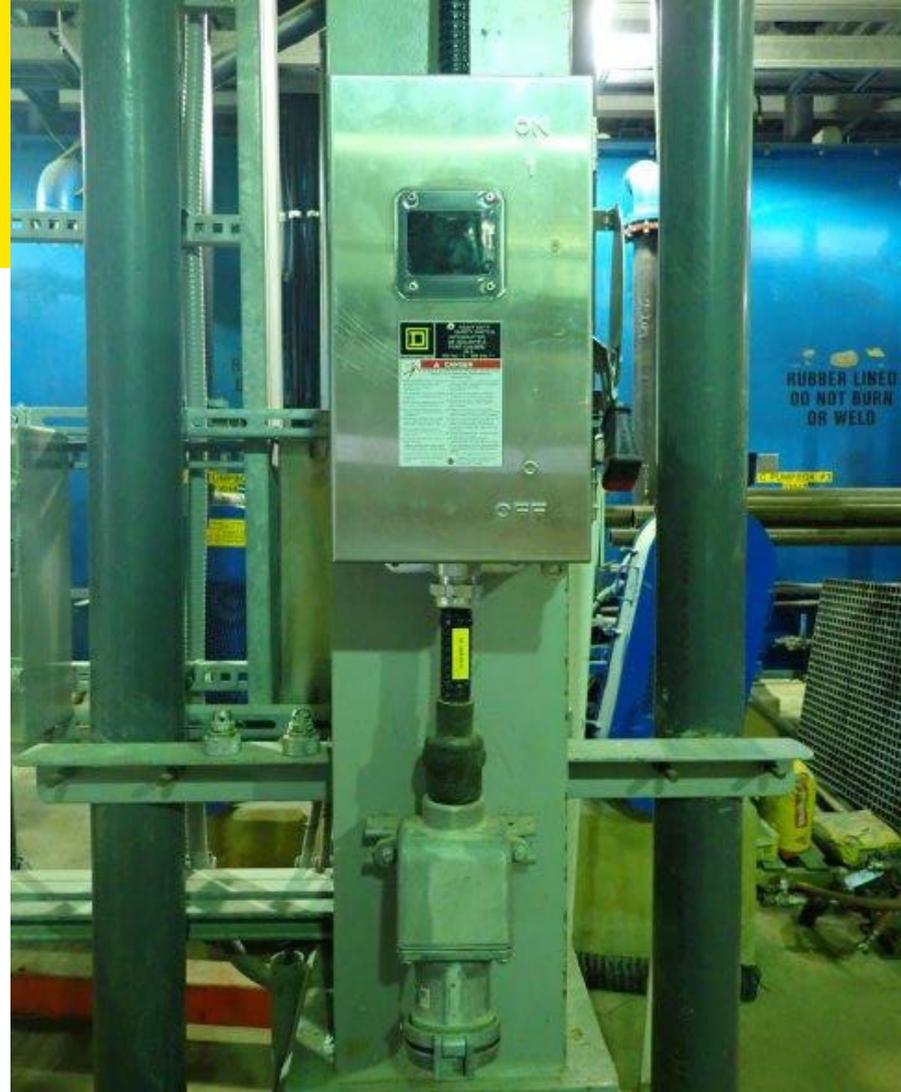
- Where 600 Volt portable equipment is being used frequently, consider installing a local visible disconnect
- This allows for a lockable positive disconnect close to the area of work
- Eliminates long extension cords and would have provided a quick safe means to disconnect the power source in this case.
