# Nutrien Cory Service Shaft Cable Failure

Cory Potash Safety Share

March 24, 2020

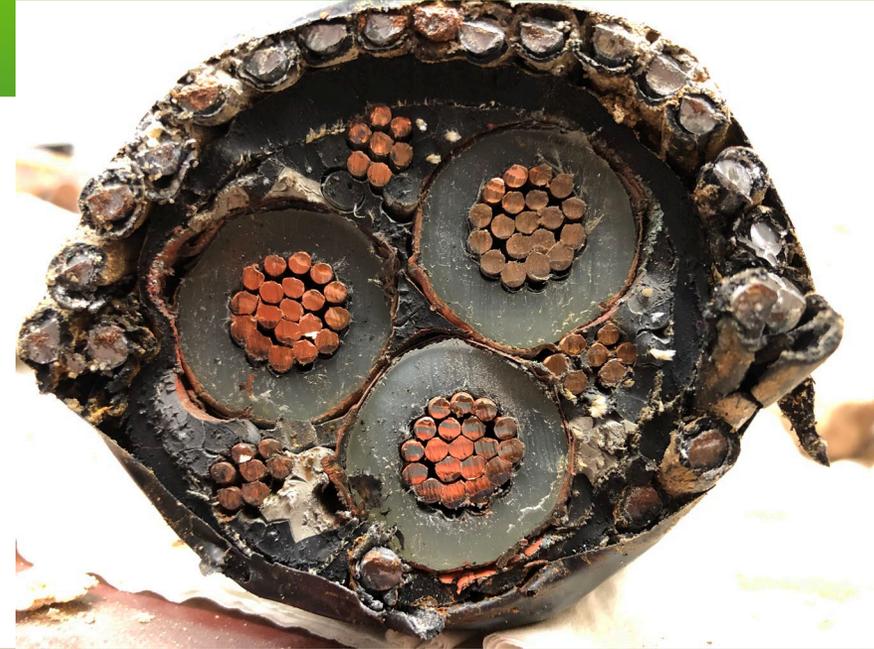
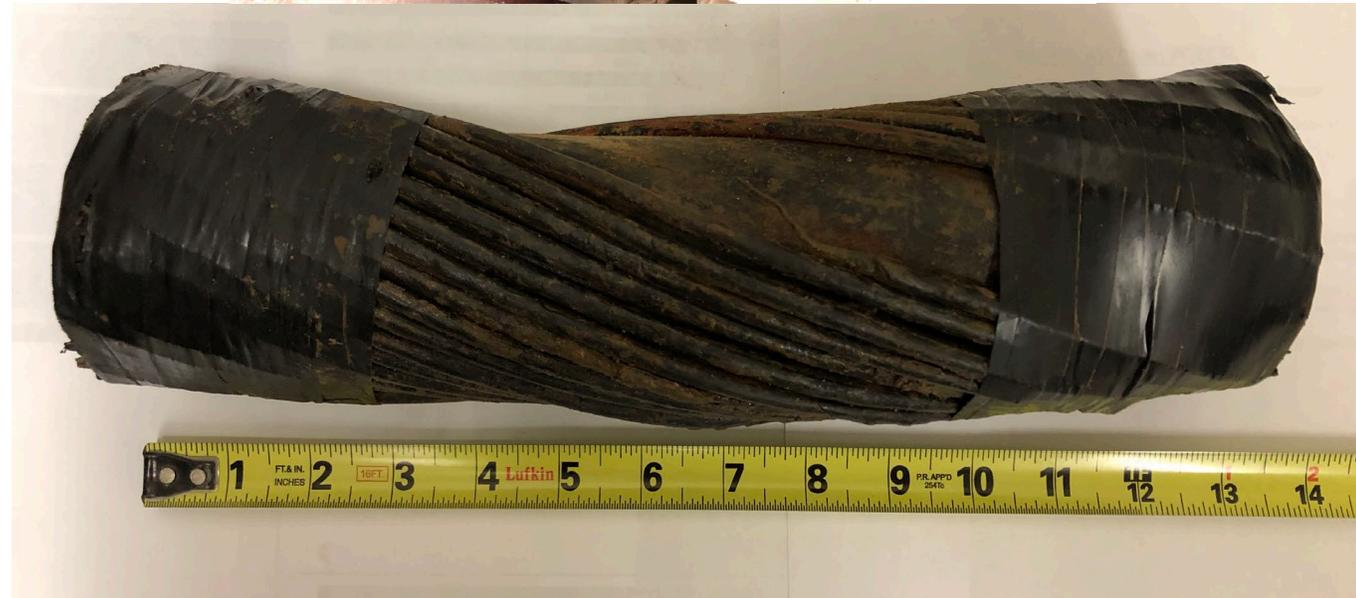
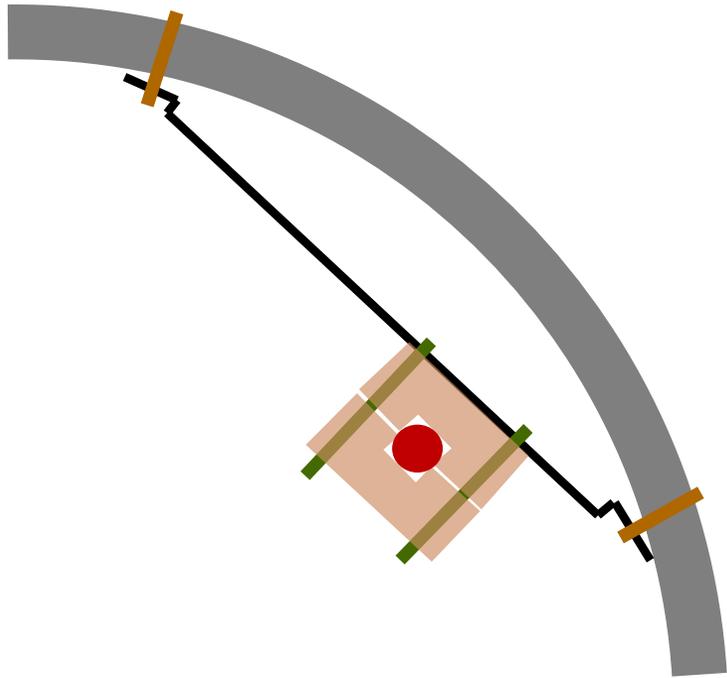
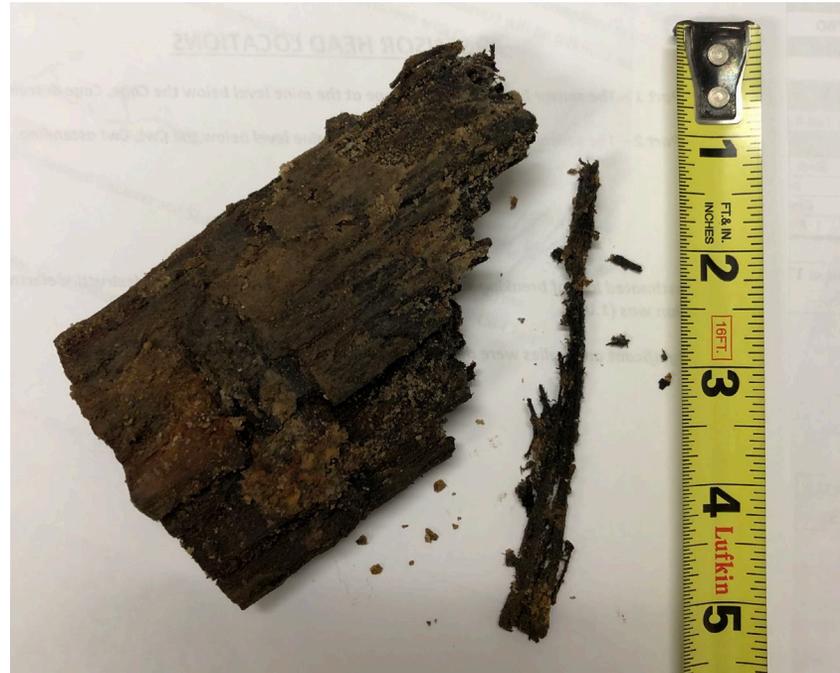
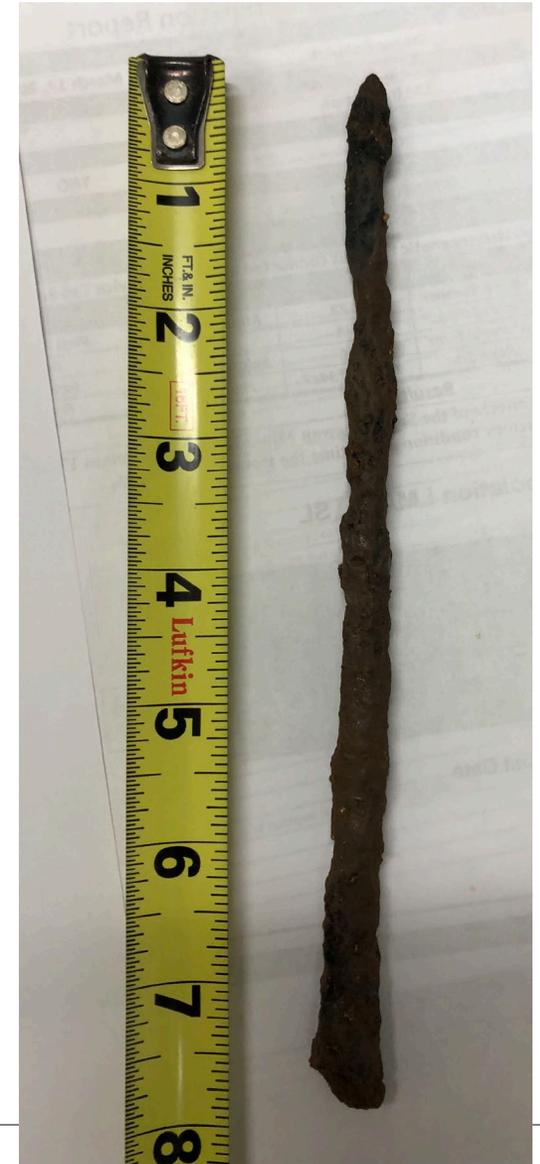
# Original Shaft Feeder

Both of Cory's shafts contained original 13.8kV shaft feeder cable that was commissioned in 1969

Metal brackets with keyholes are anchored to the concrete lining every 20ft vertically . Bolts are fed through the keyholes to support two wood blocks that pinch the 13.8kV cable in place.

Most of the blocks in the upper shafts have 6-18 inches of built up mud on top of them.

Over the years some of the blocking has been removed and there are longer stretches of cable that are unsupported.

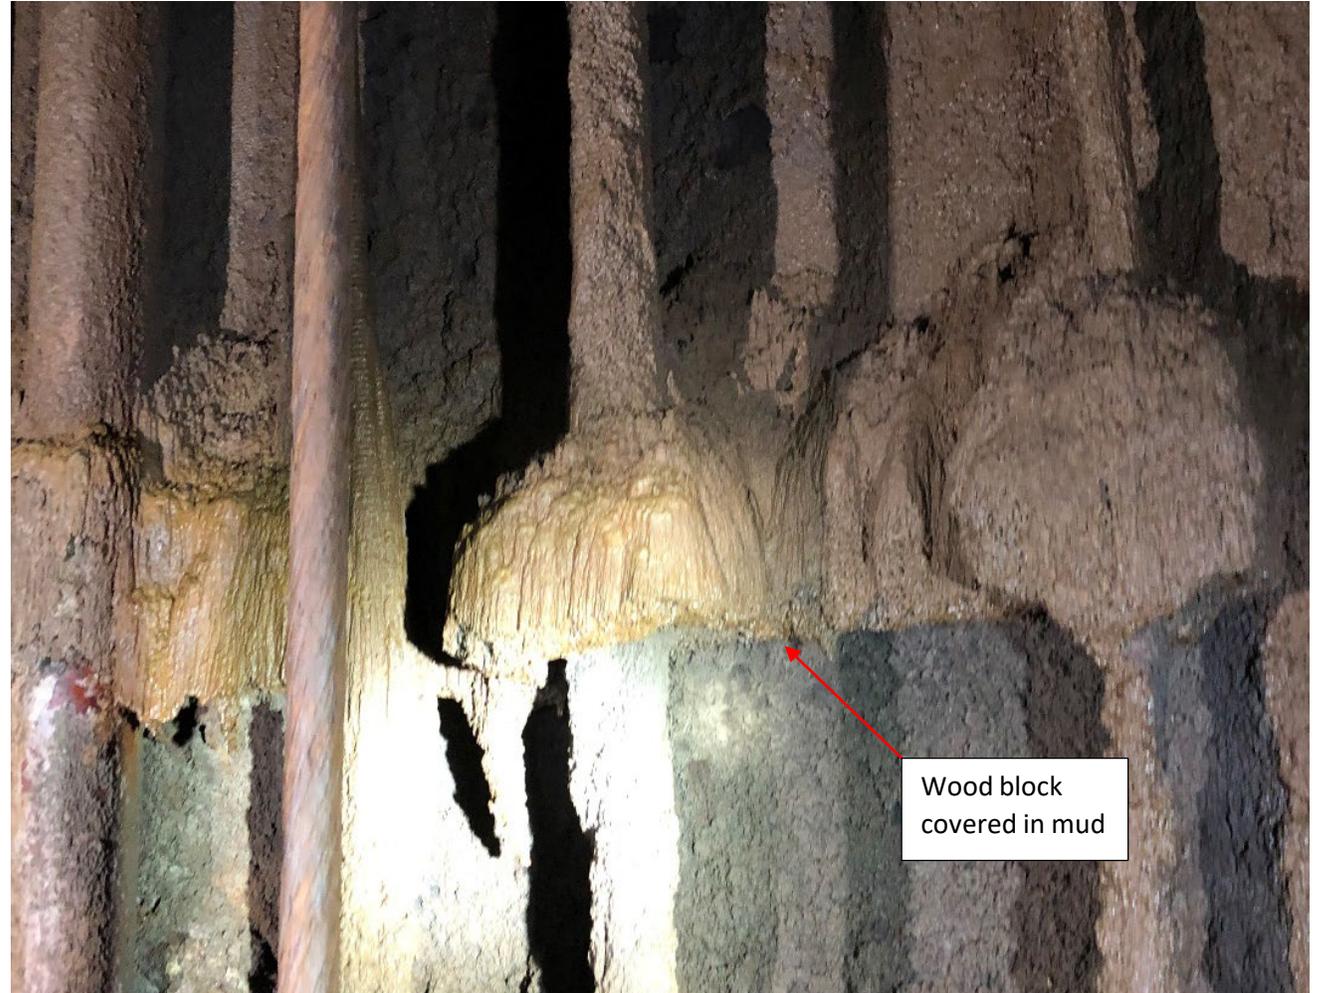
At the 2700ft mark the shaft crew had previously cut out a piece of the cable for testing. It is believed this was cut 6 months prior to the incident. The piece was to be used for testing of new hydraulic cutters.

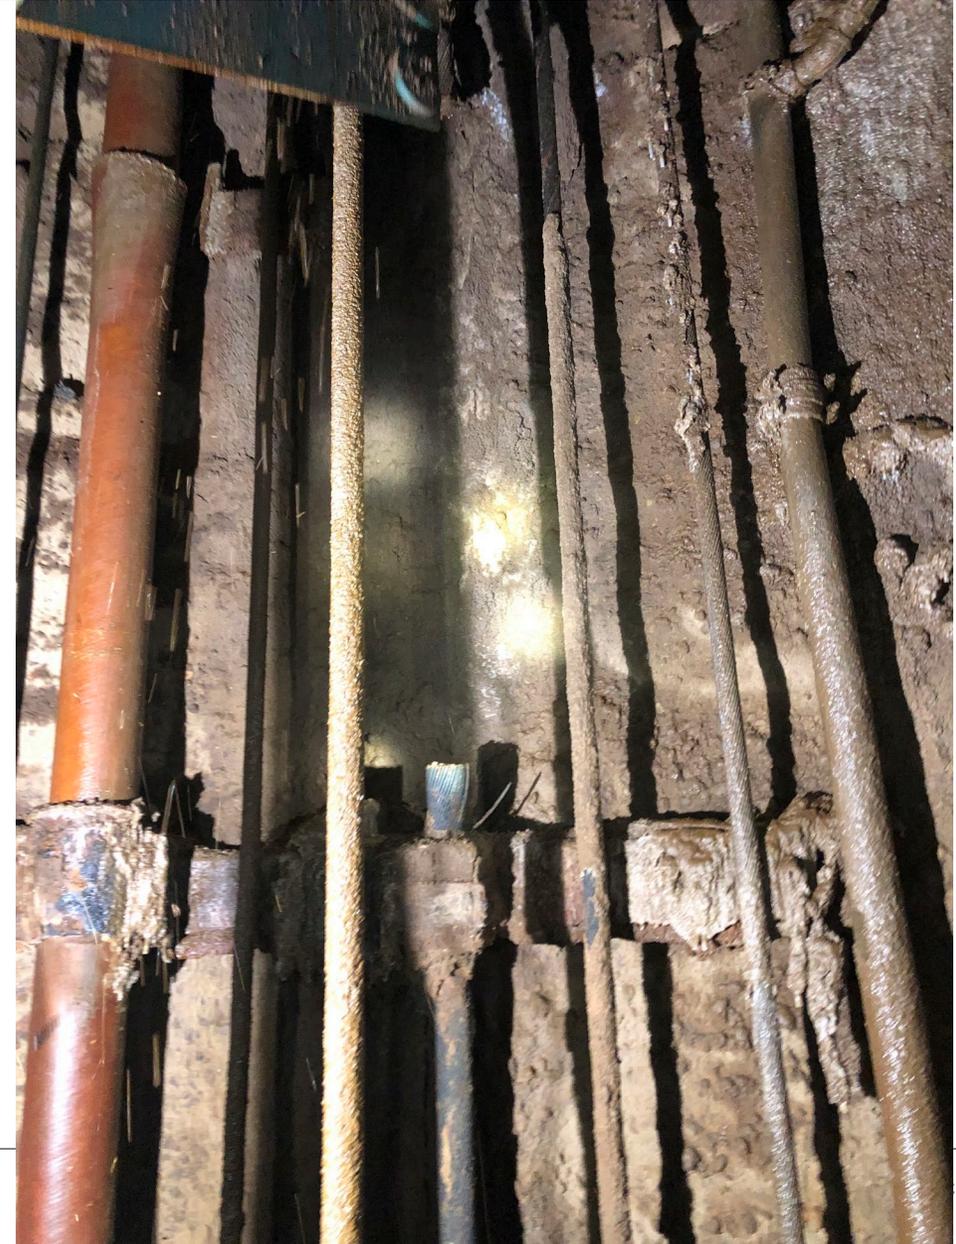
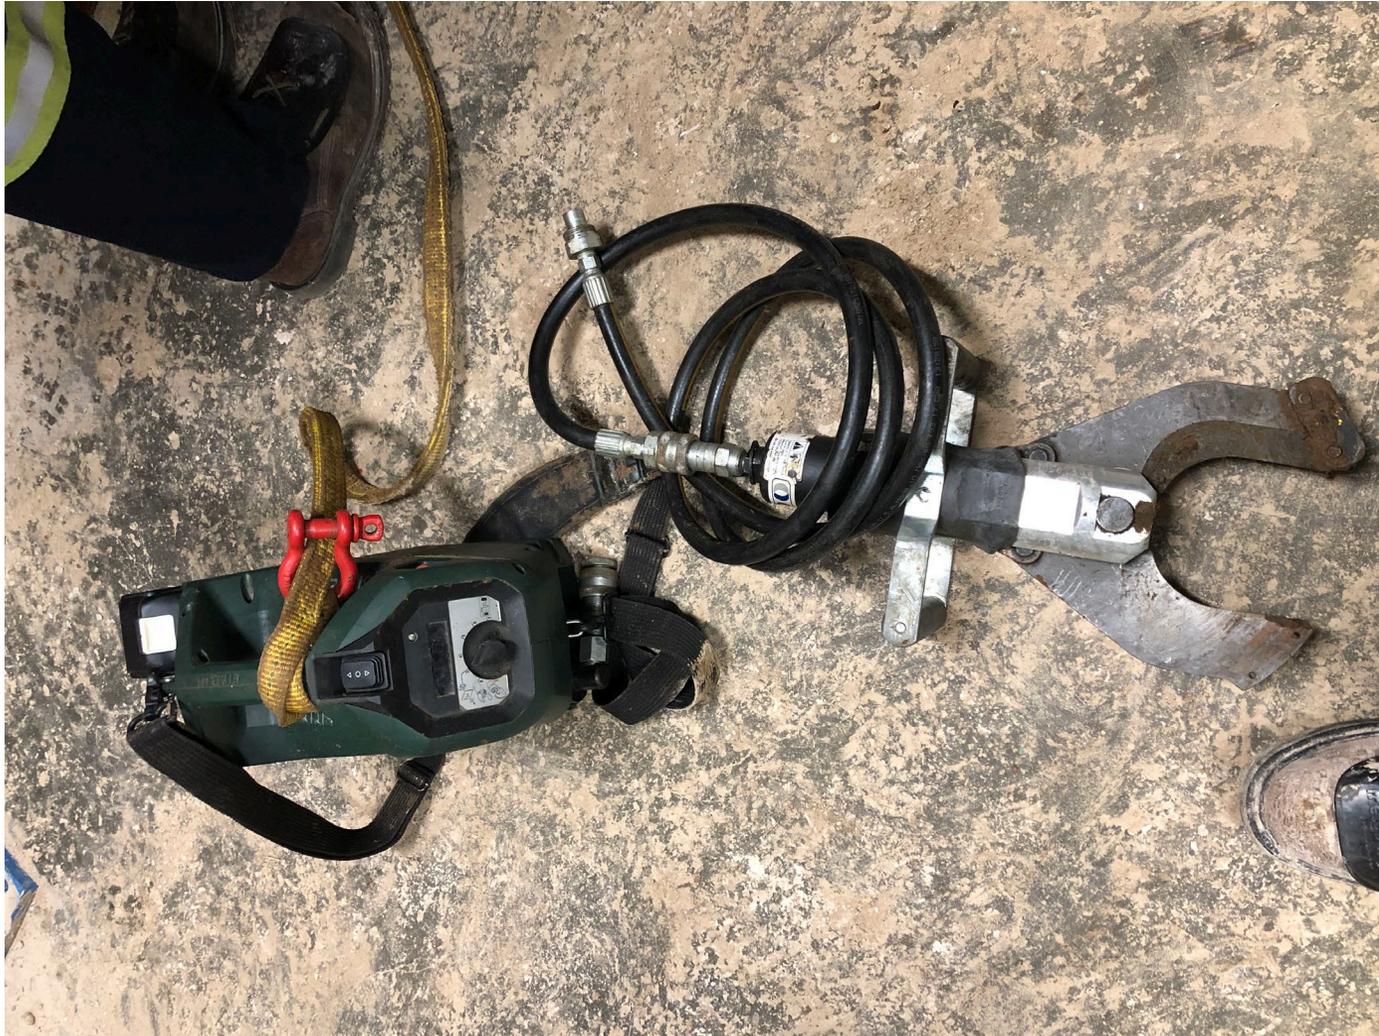
Previous cable removals would start with a shaft inspection and removal of any loose debris on the cable. Next a Sawzall would be used to cut the cable and bring 10 ft sections on the work deck before making the next cut

- The advantage of hydraulic cutter is to reduce the shaking and vibrations on the 13.8kV cable to reduce the potential of debris falling towards the operators.

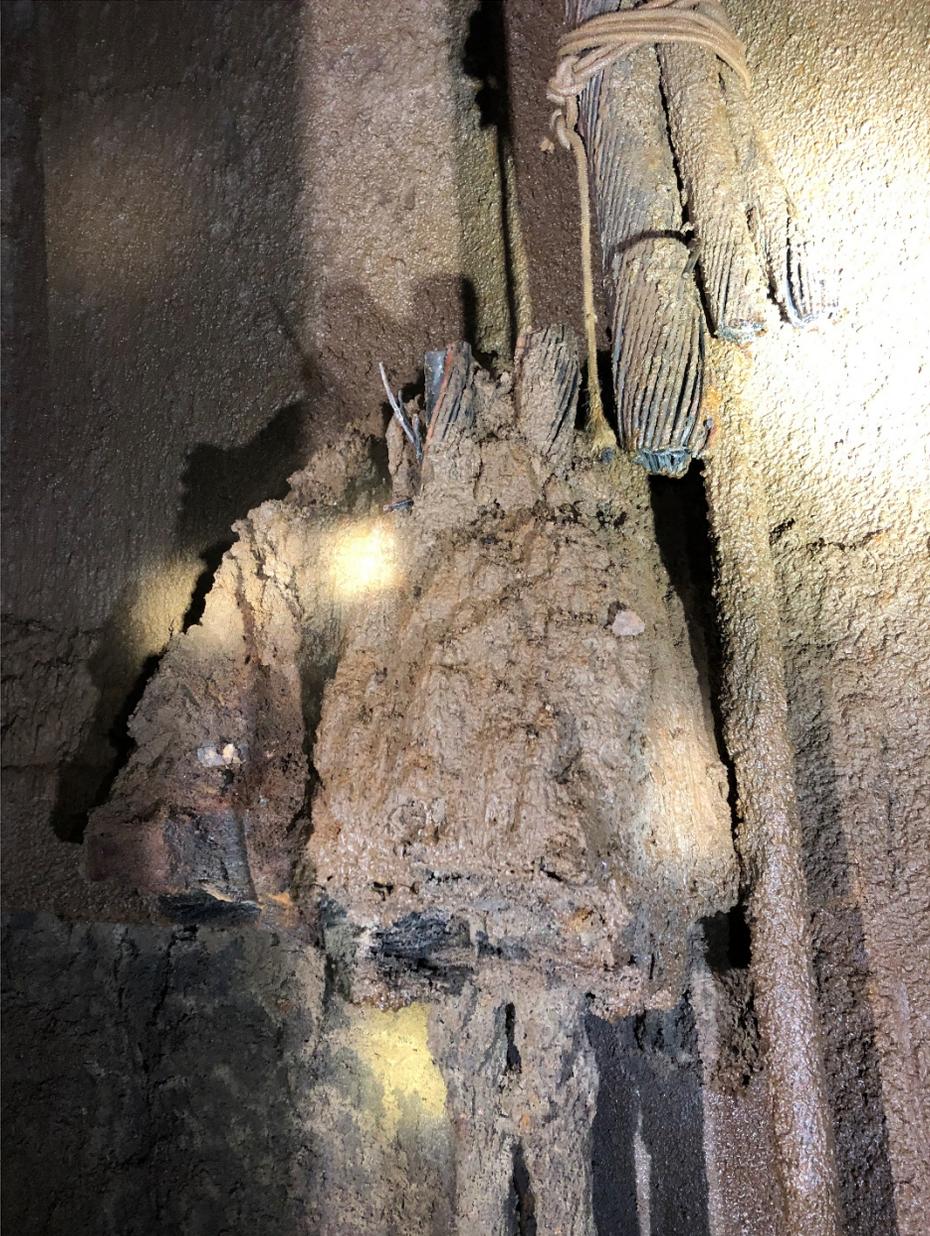
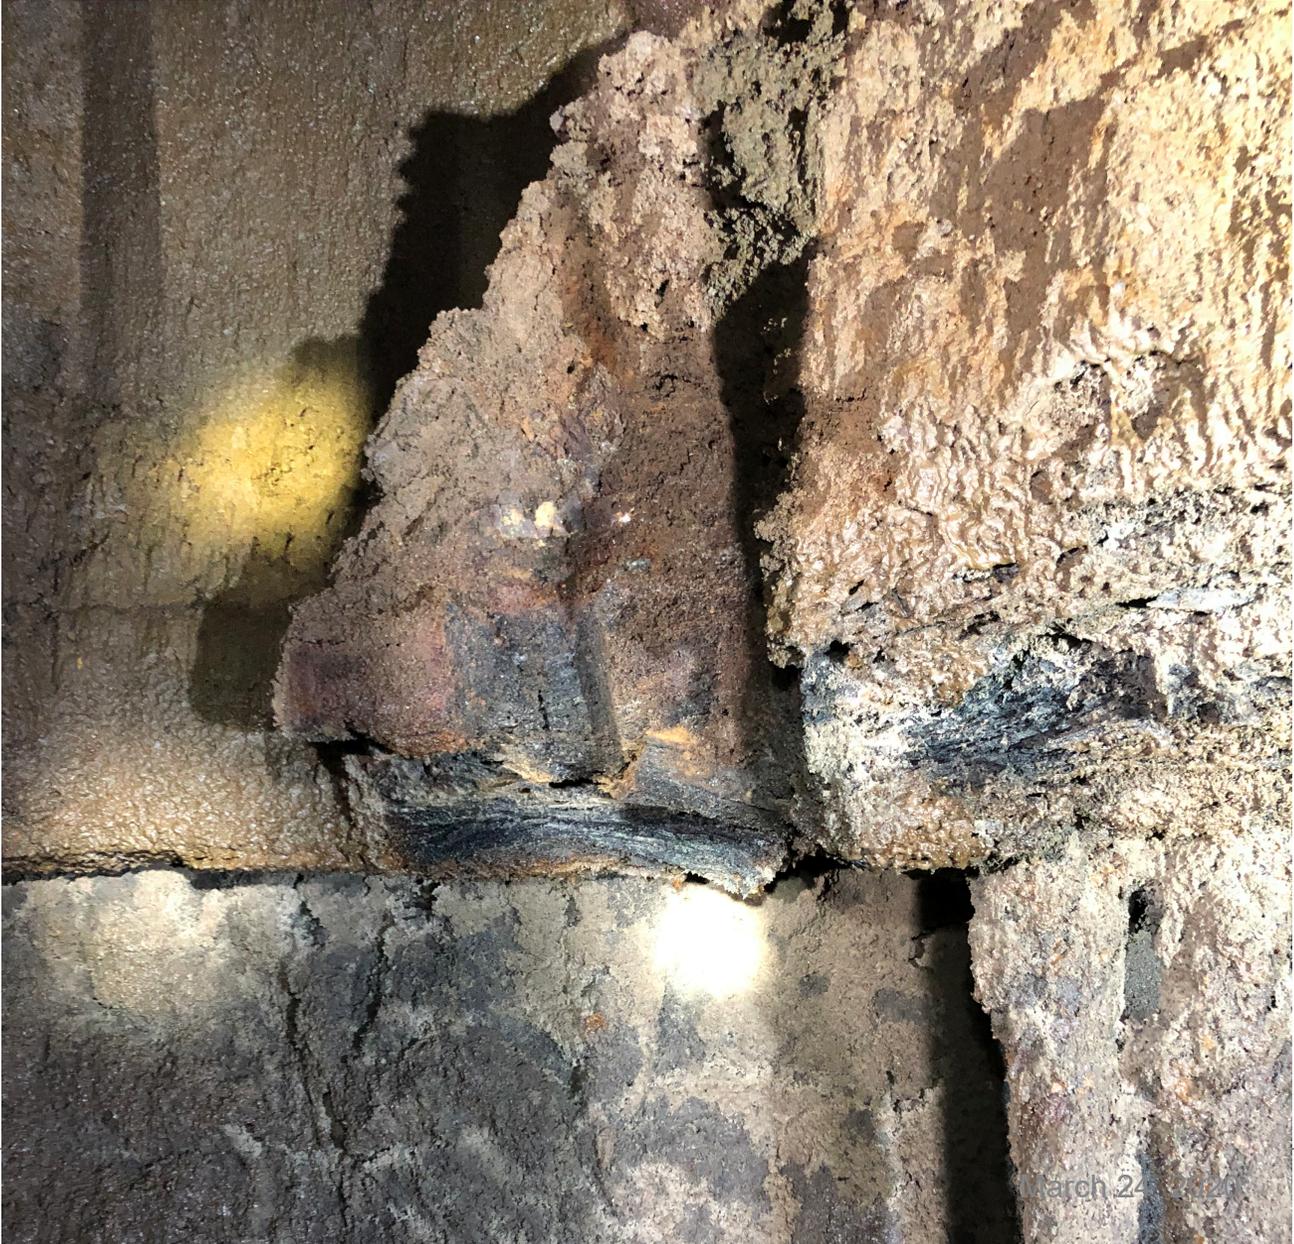
# Pictures of the 13.8kV cut point

The cable fell an approximate distance of 650ft. Between 1350 ft and the 2000 ft mark, the cable ripped through 24 blocks including one newer bracket and steel block.

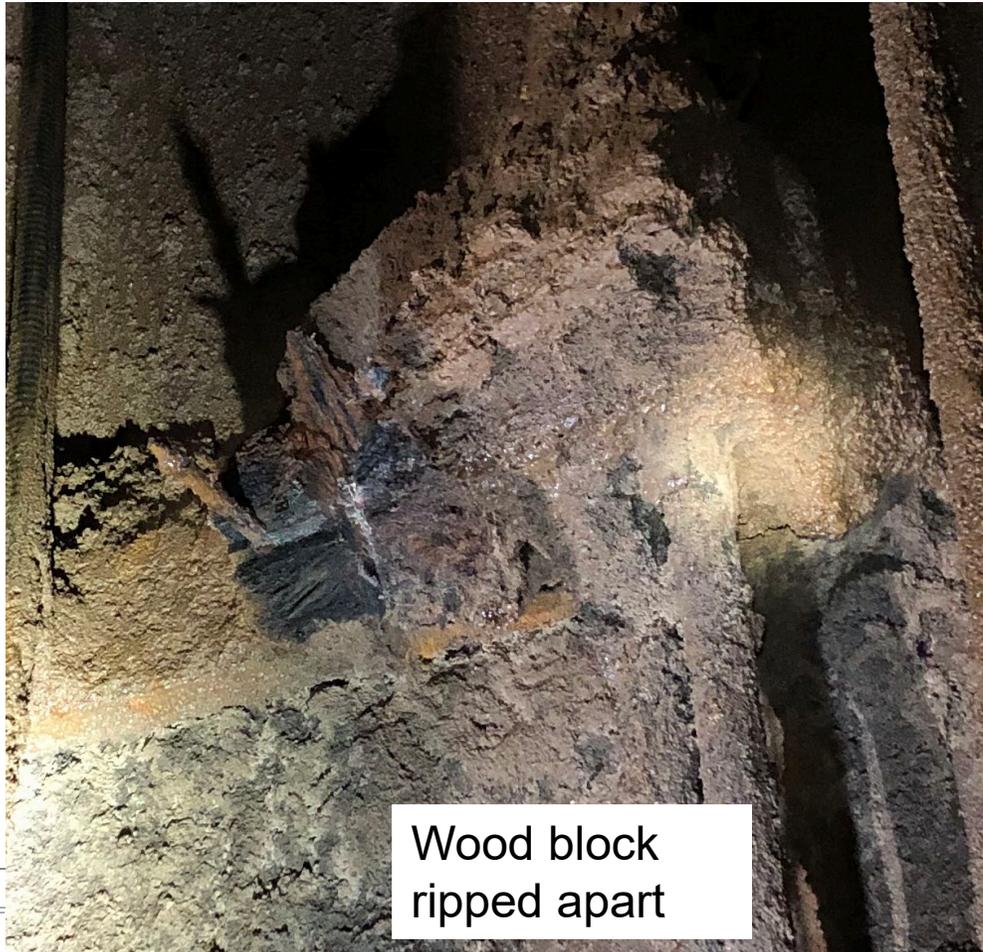
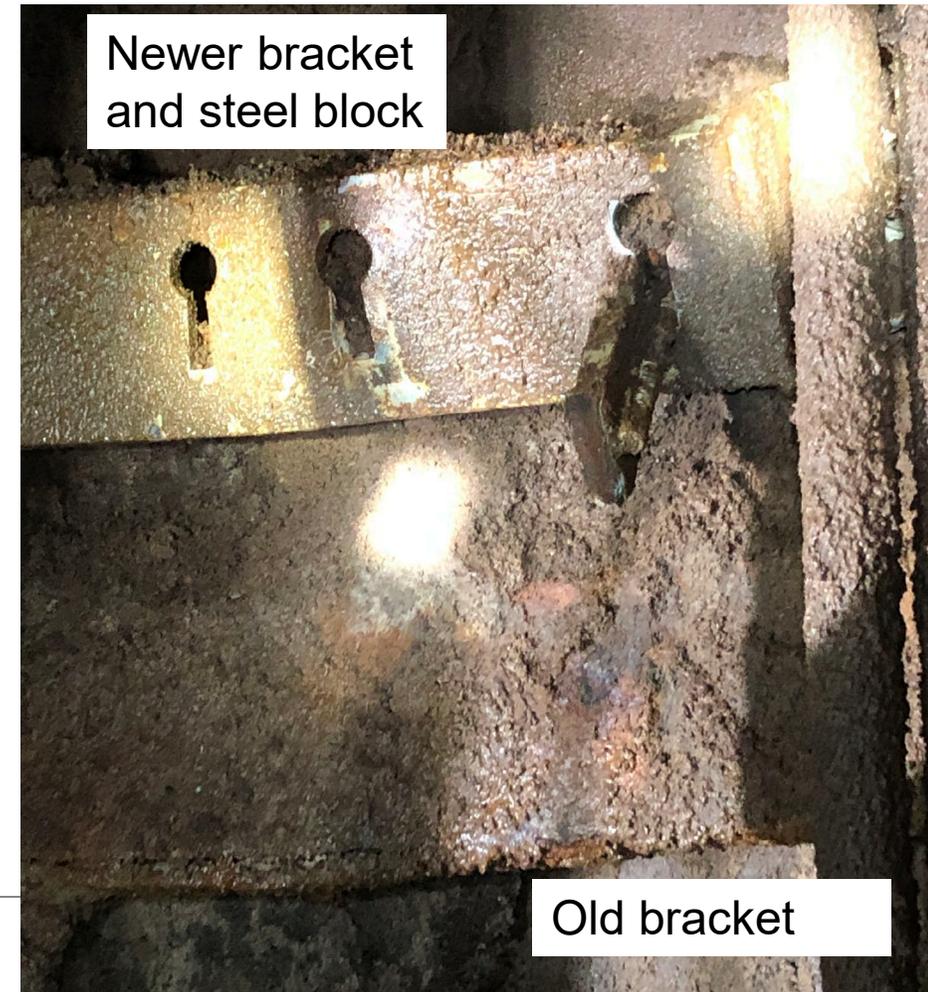
The cable fell through the tubing section and the blocking through it.

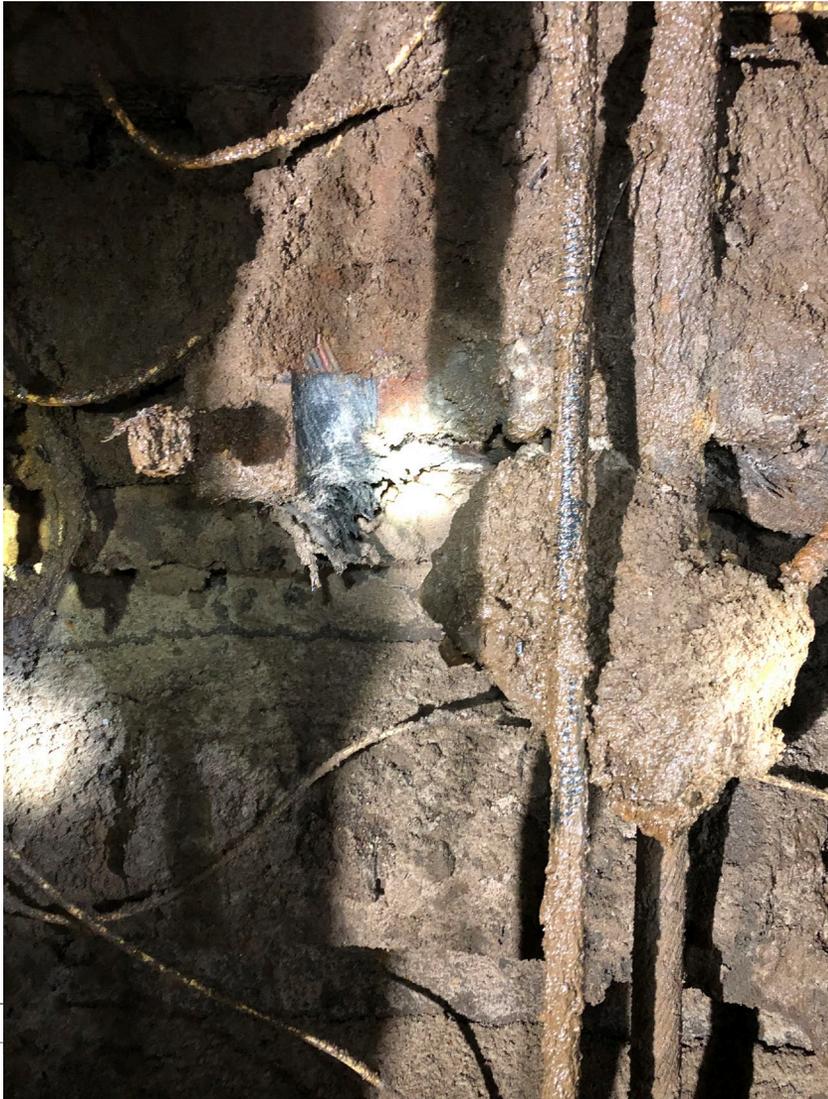
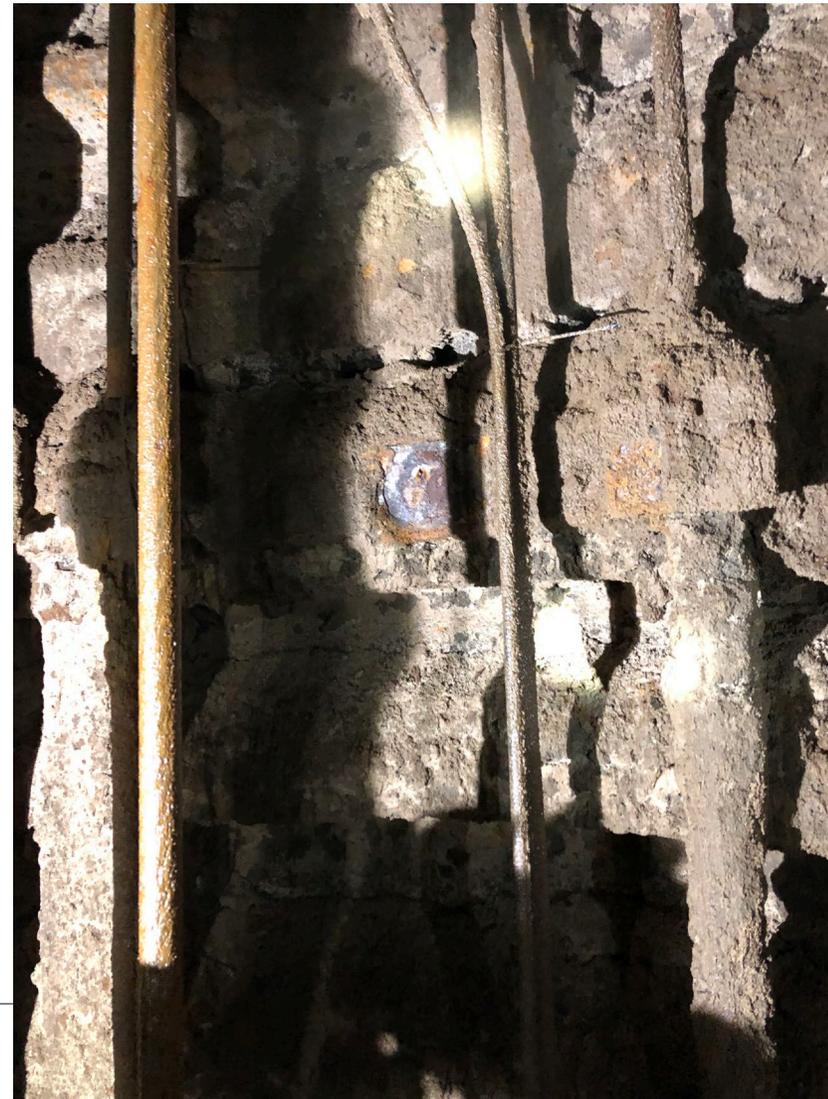
# Cable Arrested

The 13.8kV cable ripped through 24 blocks before being arrested by, a presumed, wood block with calcium build up around the block. The calcium build up is from leaks in the shaft lining just above the area.

The brackets are spaced down the shaft every 20ft, suggesting that there should have been 32 blocks holding the cable in place but, only 75% of the blocks were intact prior to incident.

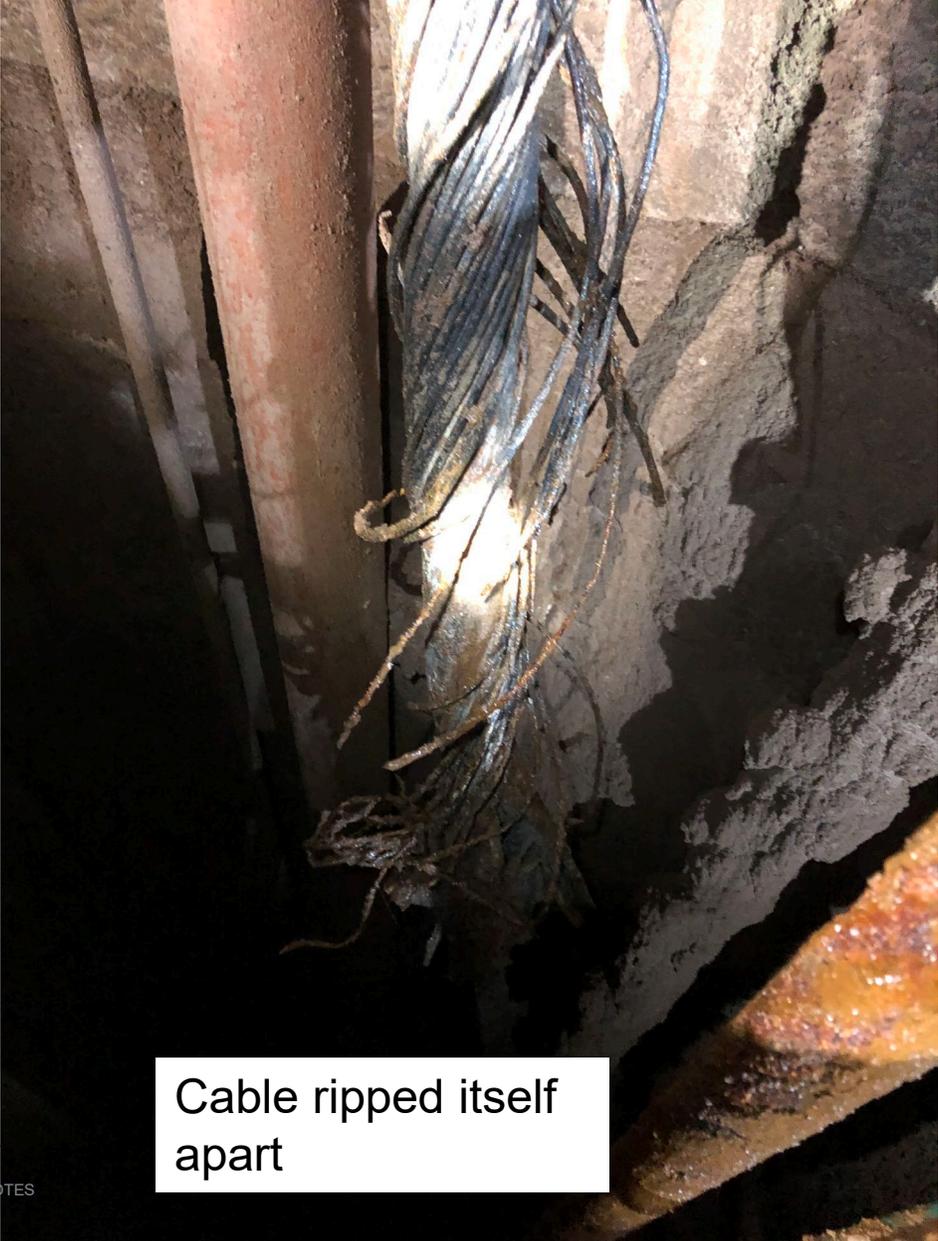
# Cable arrested in calcium coated wood block

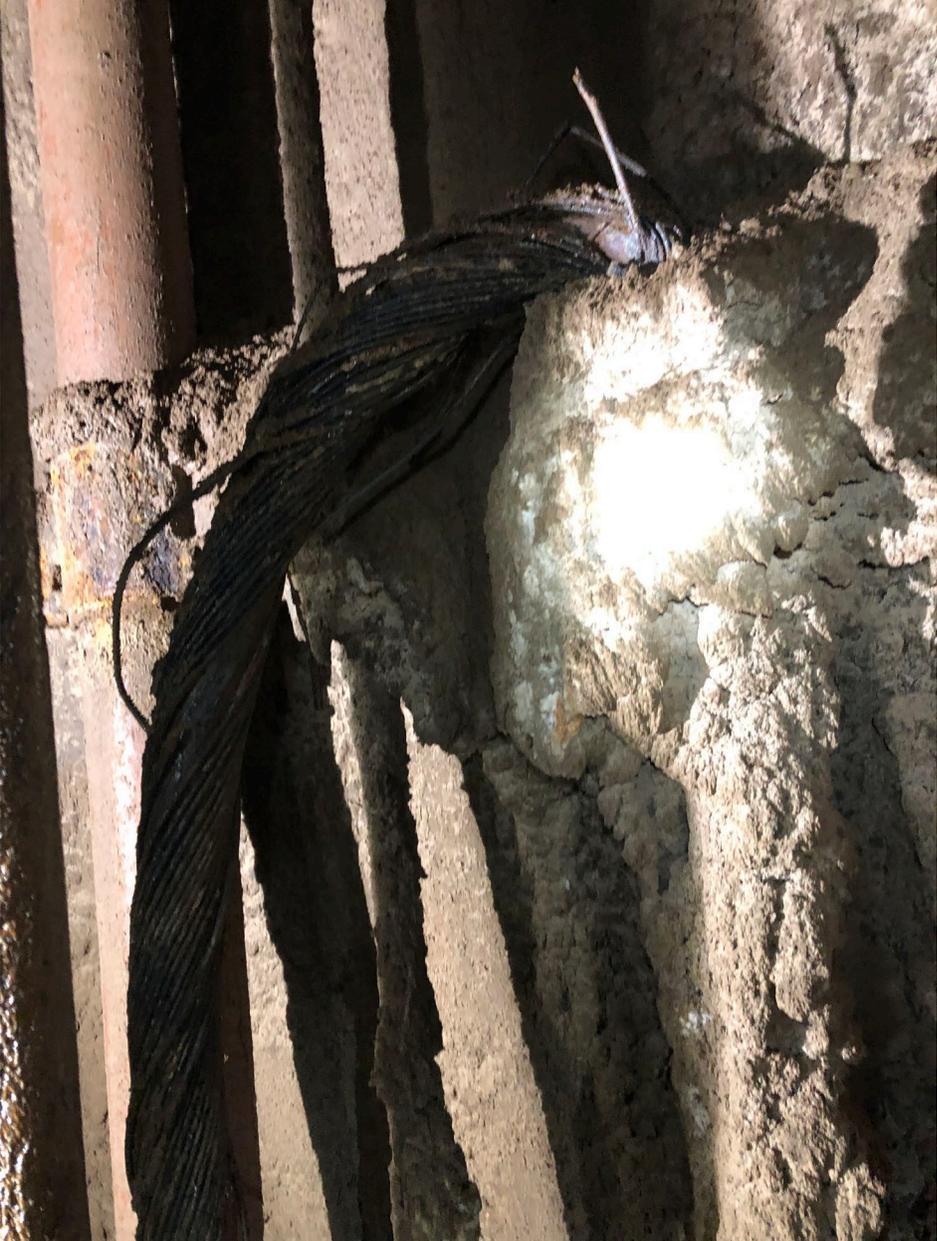
Cable ripped itself apart

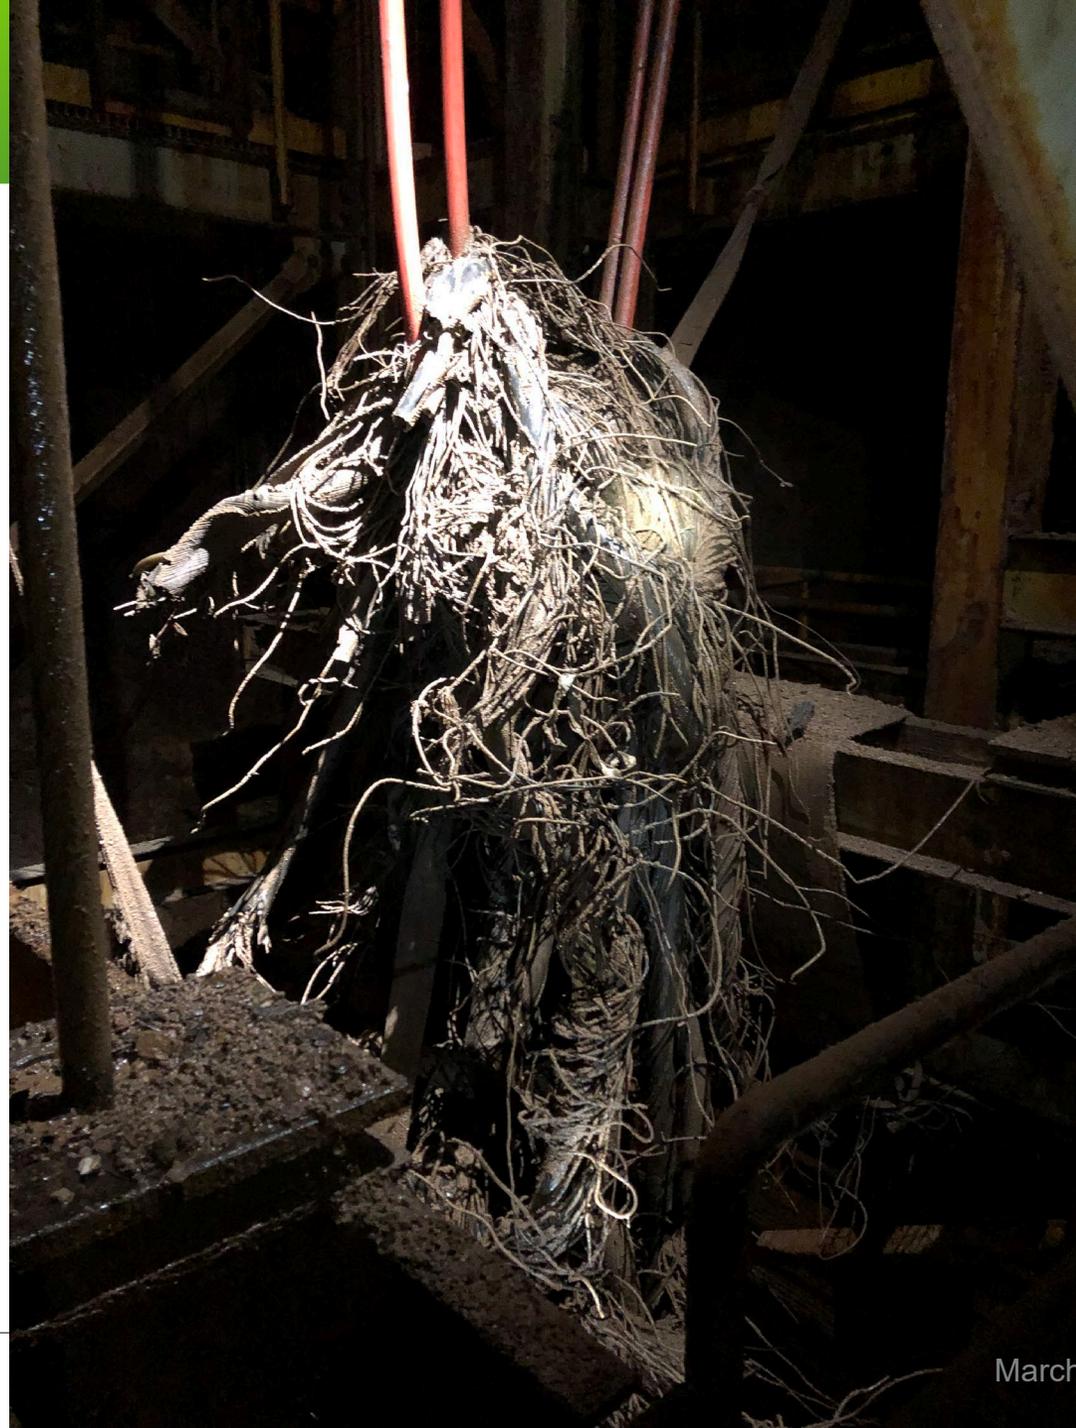
# Balance Ropes

The balance ropes caught roughly 565 ft of the fallen 13.8kV cable. A weight estimated at 4520 lbs.

The service cage with 4 workers were stranded in the shaft and 32 workers were underground with no egress. (2:00 pm July 2)

The balance ropes were freed of the 13.8kV cable the next day. Some damage was evident to the balance ropes and so they were changed out inside of the summer shutdown.

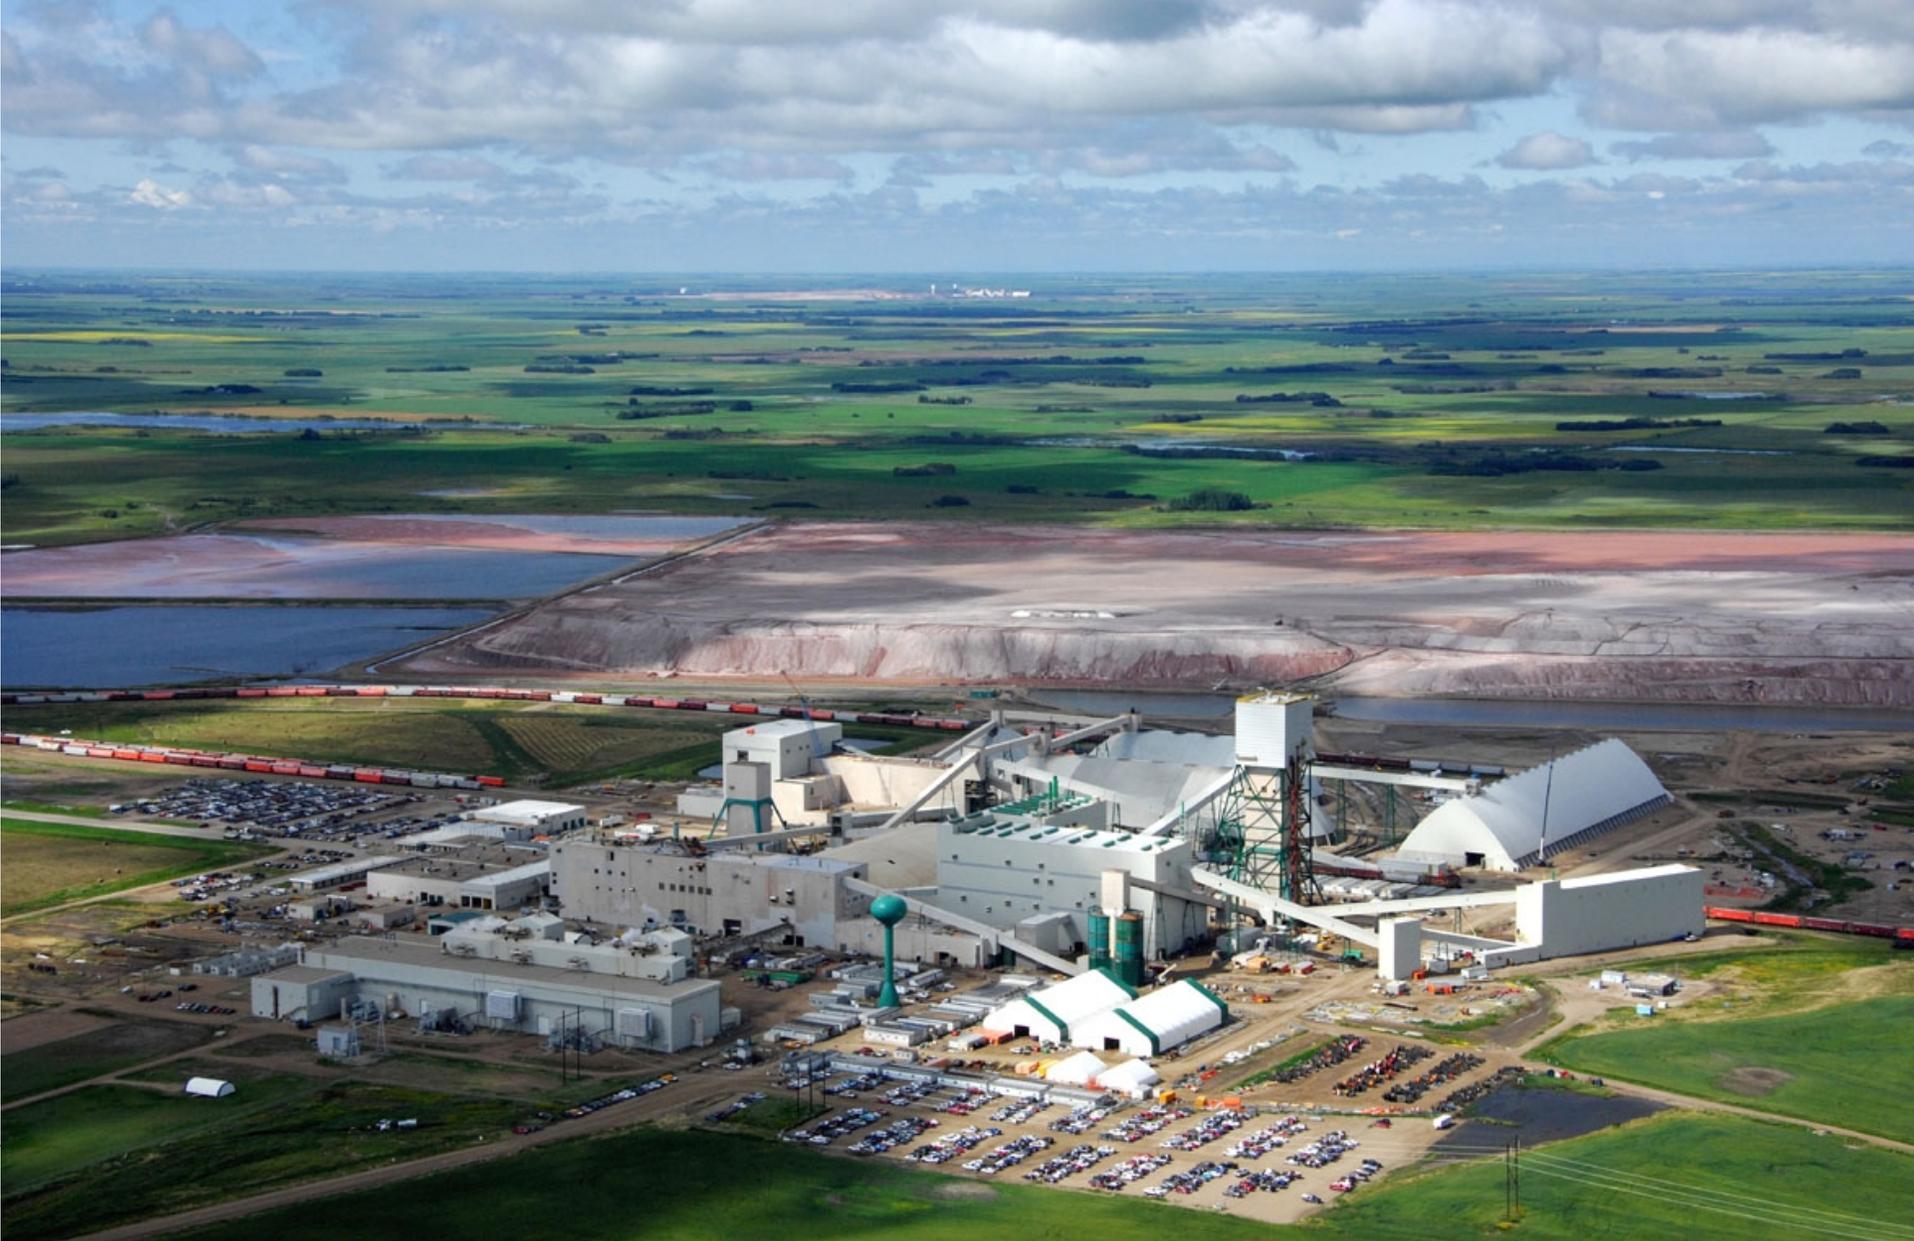
# Reestablishing Egress

The production hoist was brought back into operation at 5:30 pm July 3<sup>rd</sup> (26.5 hours after stand down)

All personnel were up from underground by 7:00 pm July 3<sup>rd</sup> (28 hours after stand down)
