Compactor Hydraulic Pressure Block Failure Incident Investigation and Key Learnings

SMA Mine Safety Summit
March 1, 2018

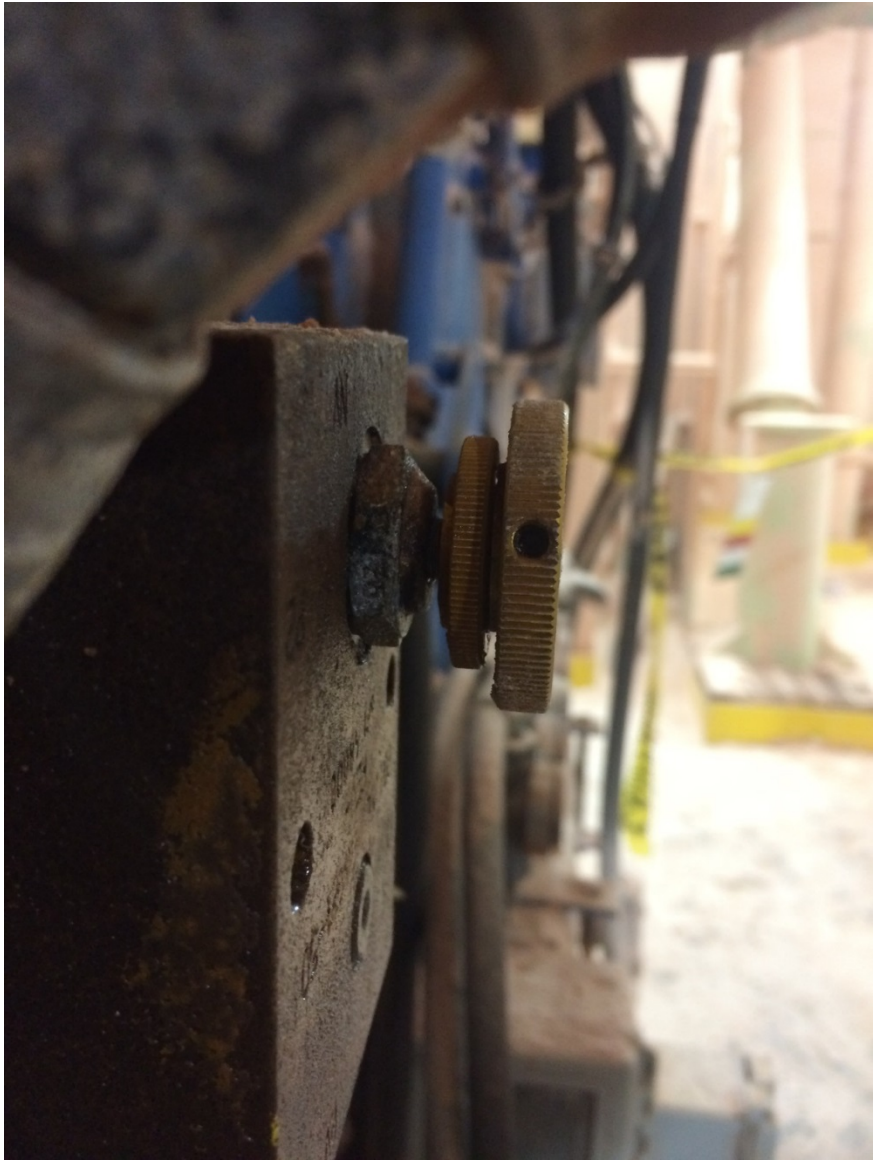
No.	Cause (select from drop down menu)	Cause Description	Detailed Corrective Action
1	Personal - Training or Skills	Operator was unaware of the hazard of over torquing a hydraulic valve	Communicate incident and corrective actions to all site. So all employees are aware of the risks.
2	Maintenance - Poor Preventative	There was no spare set screws or adjustment knobs readily available	Setup spare parts for block and valve assembly as required.
3	Behaviour - Line of Fire	Possibility for oil injection injury	Hydraulic risk training. Monthly C3 meeting topic. Include hydraulic pressure, oil injection, and over torquing.
4	Maintenance - Mechanical Failure	Oil was bypassing the system preventing compactor from reaching operating pressure	Check for proper operation of all similar valve assemblies and repair / replace as required.
5	Condition - Design or Engineering	Can not close compactor feed gate to easily isolate #18 compactor	Resolve all 6 feed gates in comp 3 so they can properly operate, allowing equipment to be isolated.

6	Procedures - Not Adequate or Missing	Operator tightened the valve	Create SOP for Ludmen compactor which details when operators can adjust valves while equipment operating.
7	Procedures - Not Adequate or Missing	Operator tightened the valve	Update Lockout procedure for Ludmen Compactors. Sequence in a procedural way.
8	Condition - Design or Engineering	Hydraulic valve located in a position that could hit employee	Determine if use of hydraulic valve block assembly is necessary or if it can be eliminated. If valve assembly can be eliminated initiate MOC prior to removal.
