SMA SAFETY SUMMIT 2018

**Bethune Mine
Tailings Pile Dozer Incident**

**March 1, 2018
Garry Sawkey**

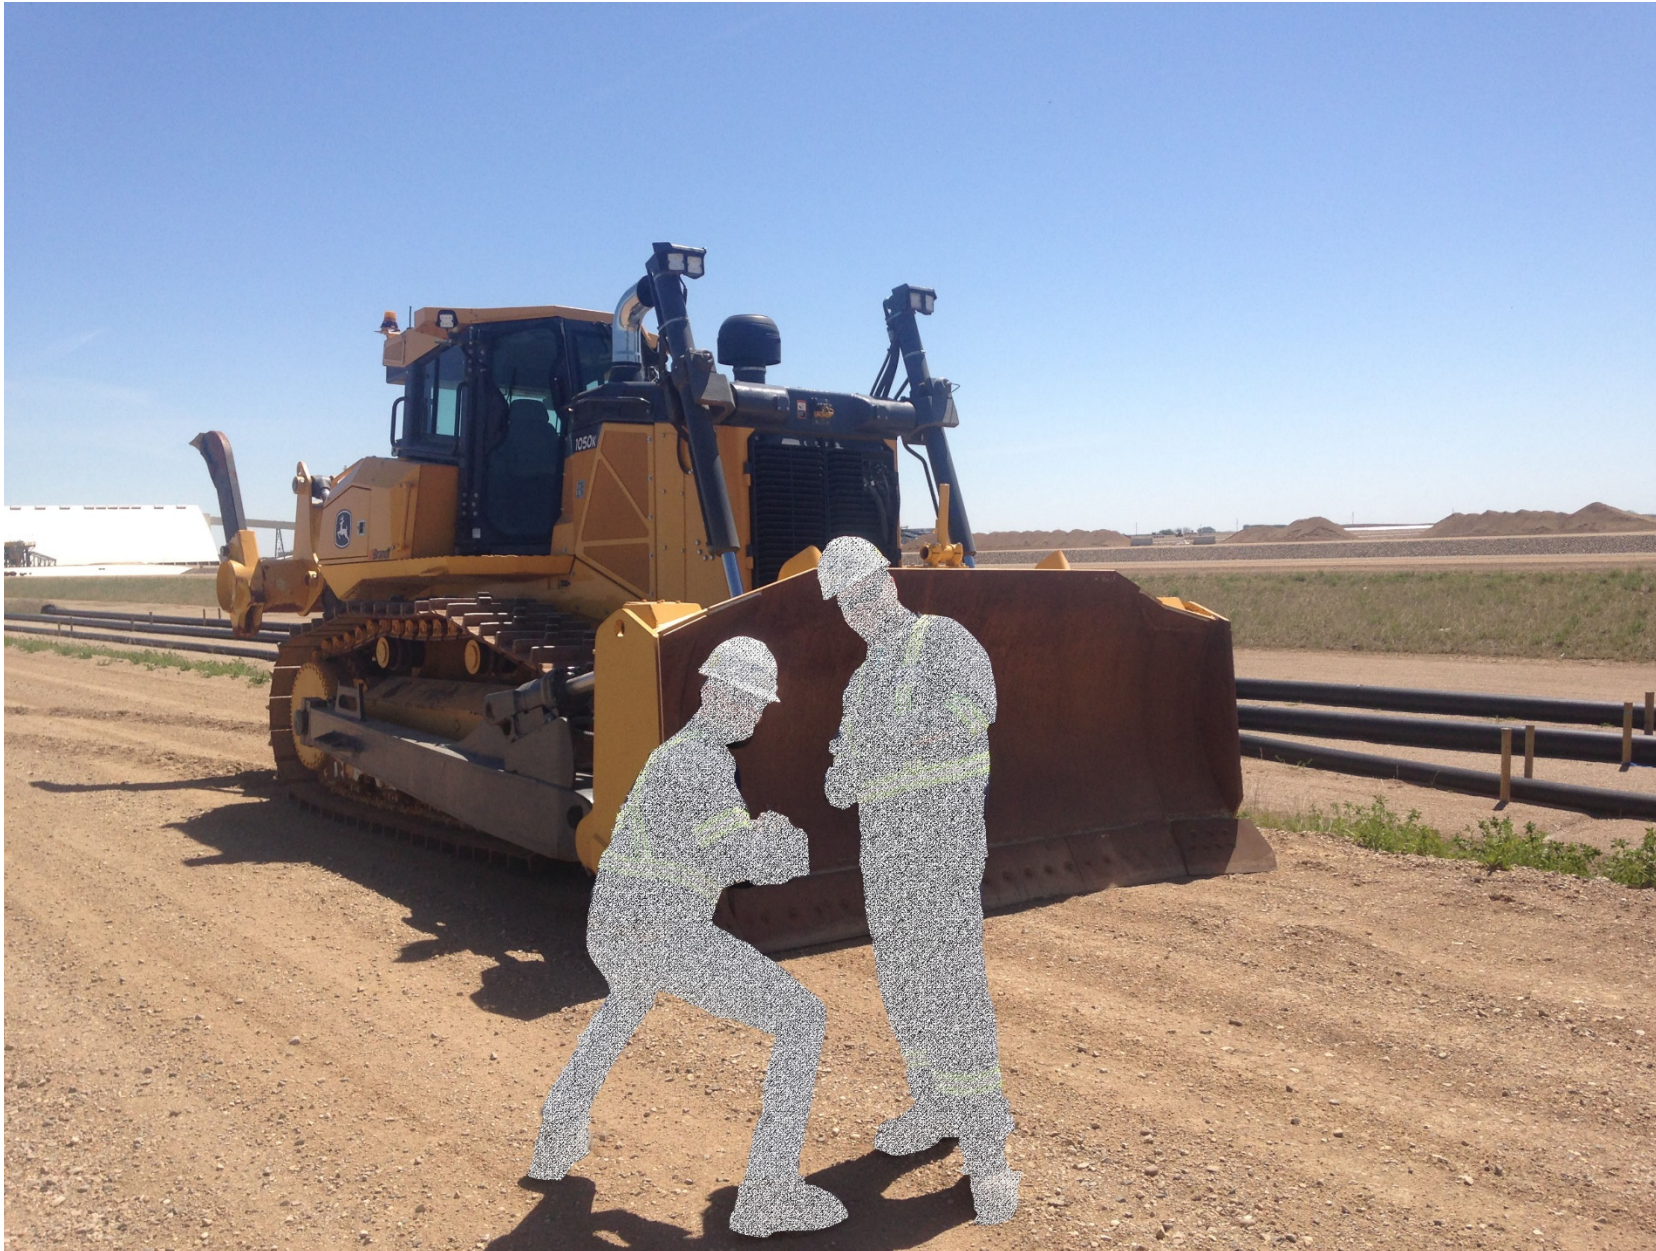
Tailings Pile Dozer Incident – Before

Dozer ready for action
May 2017

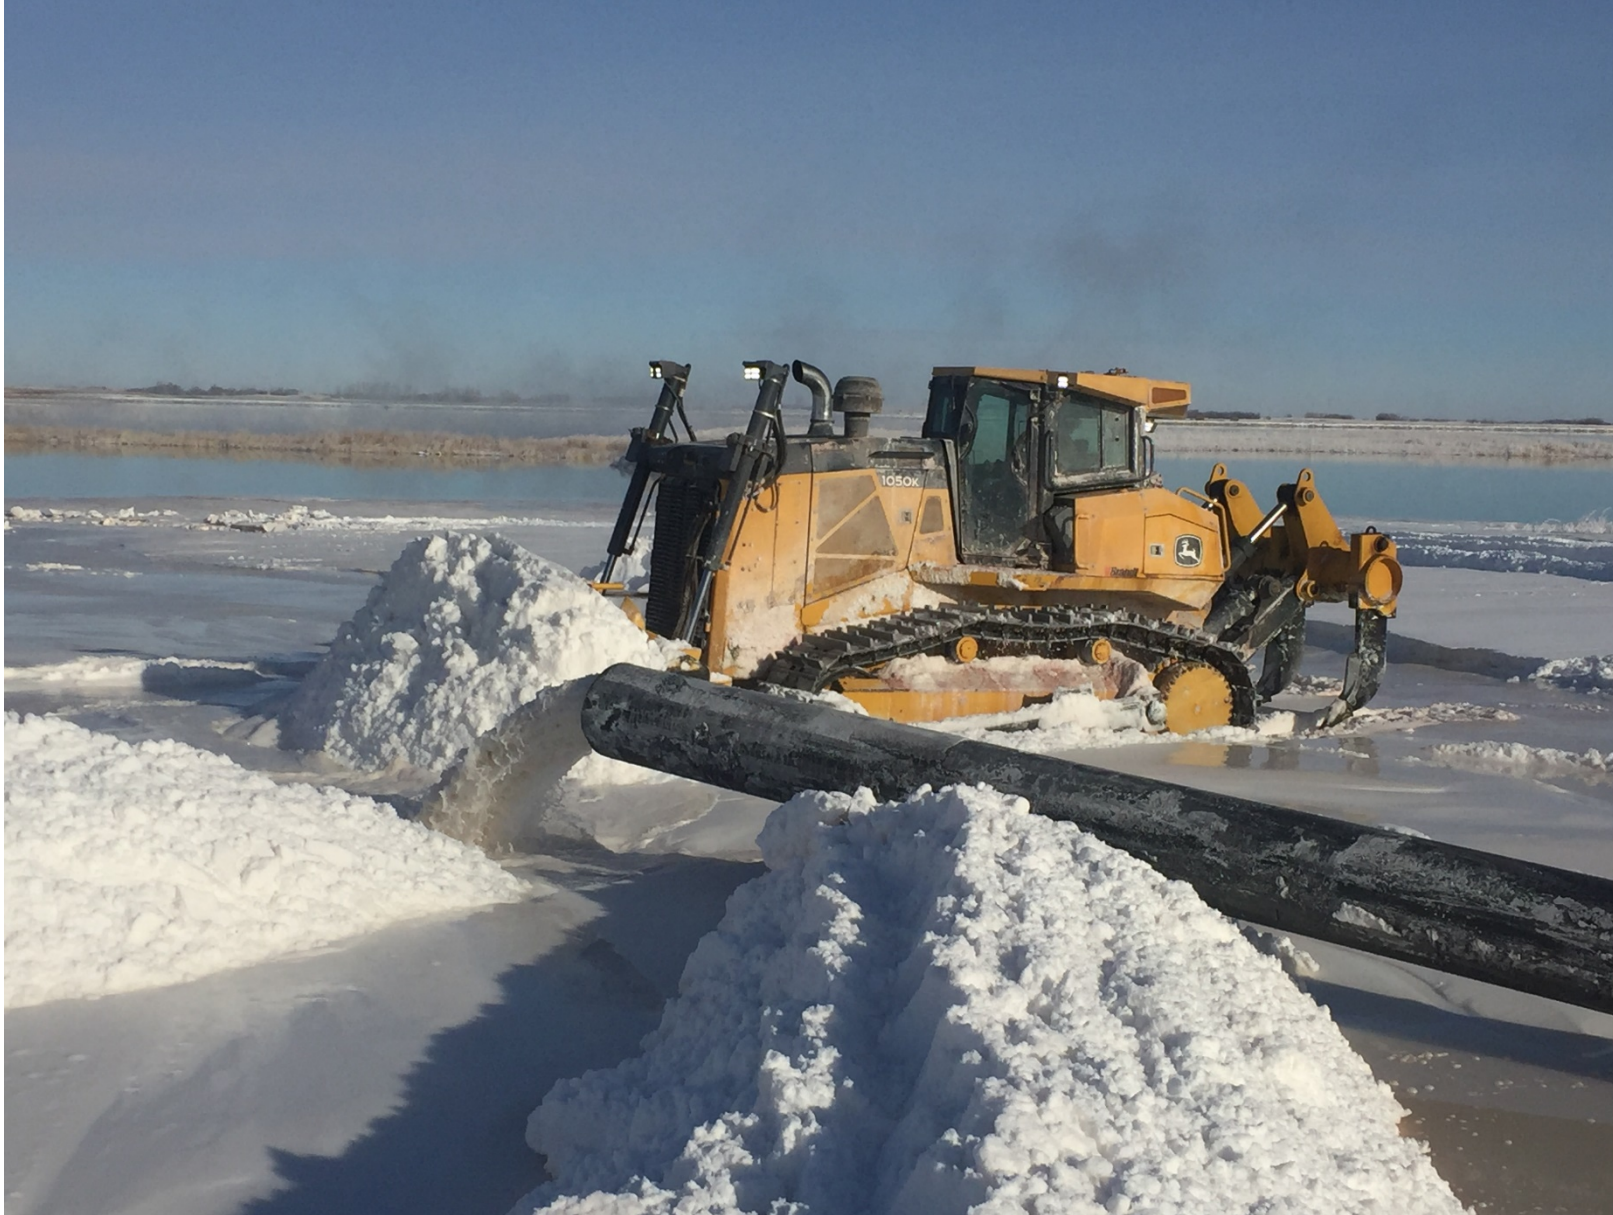
Tailings Pile Dozer Incident - Task Being Performed

Moving tailings to build elevated platform for discharge line

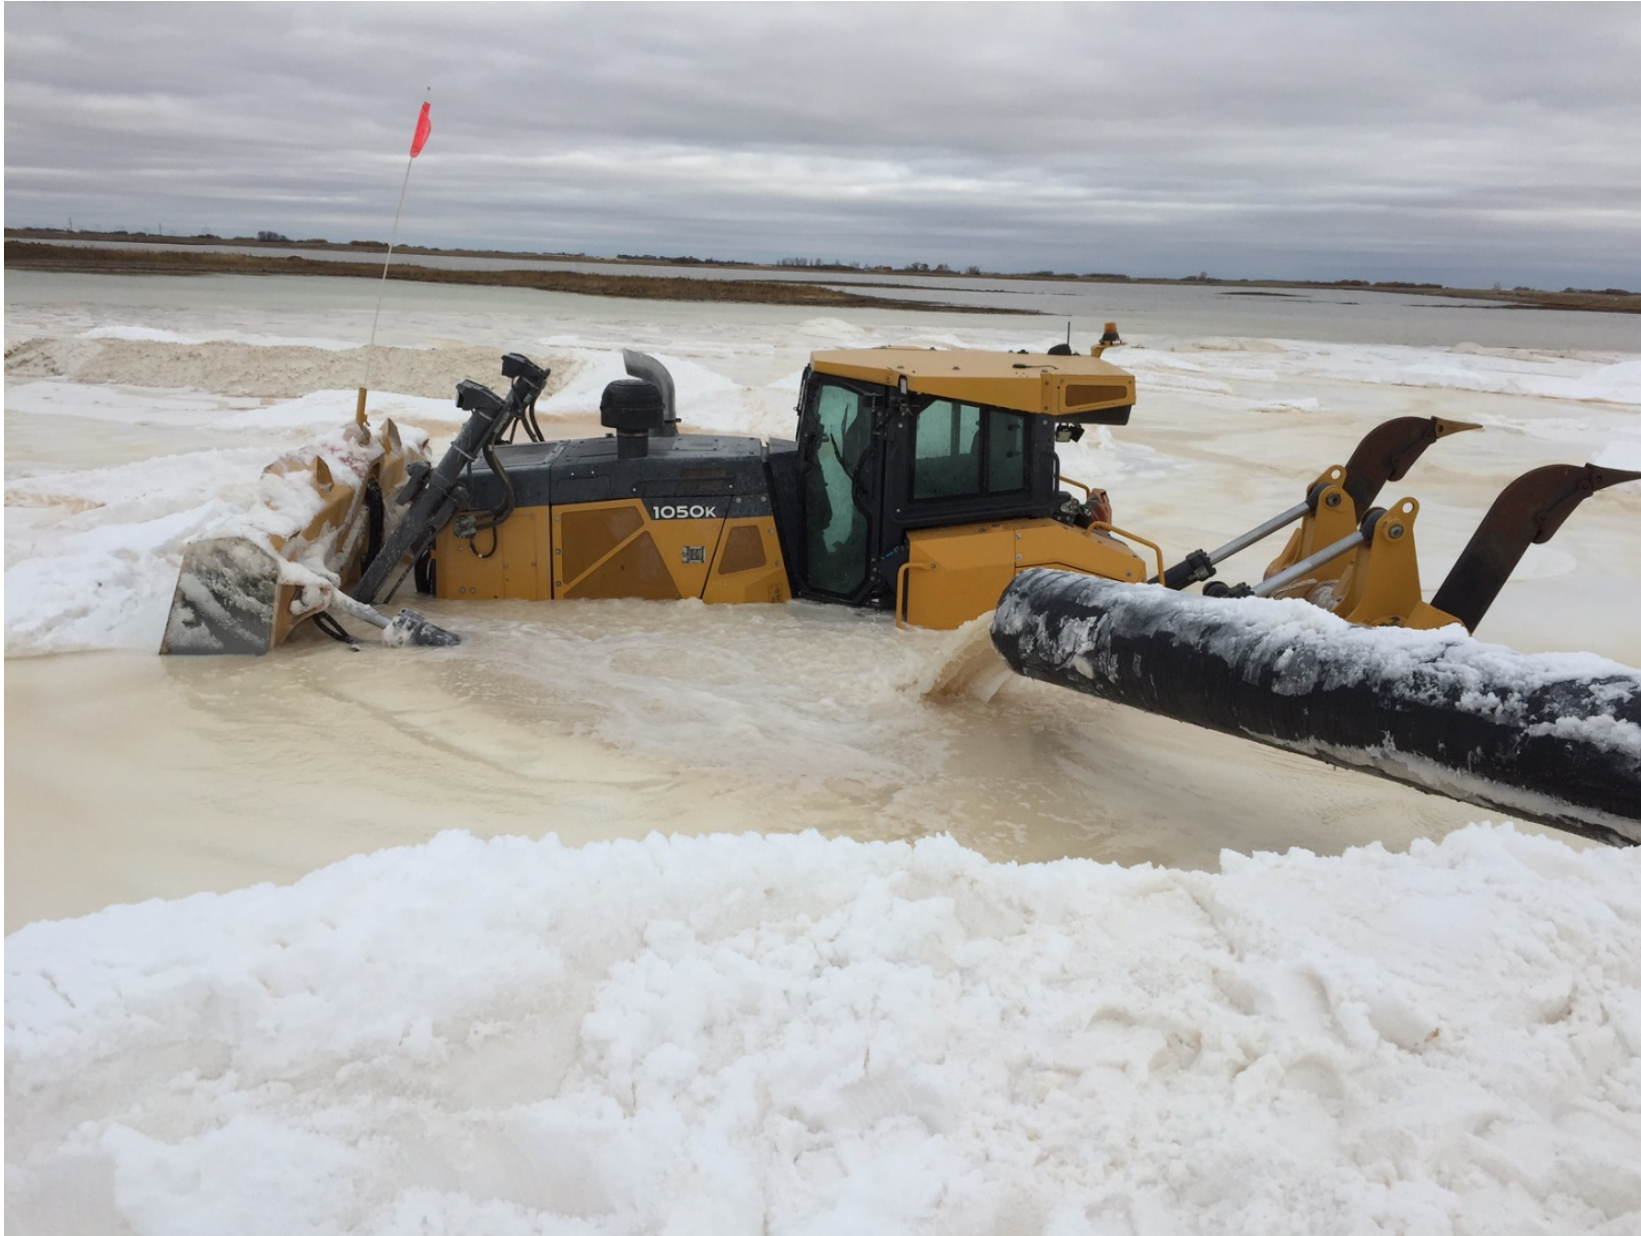
Tailings Pile Dozer Incident – The Result – Oct 2017

Operator came too close to discharge point.

Weight of salt load and dozer blade exceeded limits of salt edge and pulled dozer down.

Operator tried to self correct but failed to do so and was pulled into hole. Evacuated immediately.

- **Operator Competency in Tailings Environment**
 - Assumed operator experience aligned with SOW and contractor quote - on paper exceeded expectations – did not align
 - Dozer operation competency was confirmed in field – salt tailings different from any previous work operator completed.
- **Operator did not fully understand the hazard**
 - Pour point hole - Hazard was discussed but not identified on JSA including safe operating distance
- **More rigorous vetting of contractor experience**

- Don't rush! Spend the time to field verify contract work prior to start of work, as you would your own employees
- Ensure Scope of Work clearly identifies experience requirements

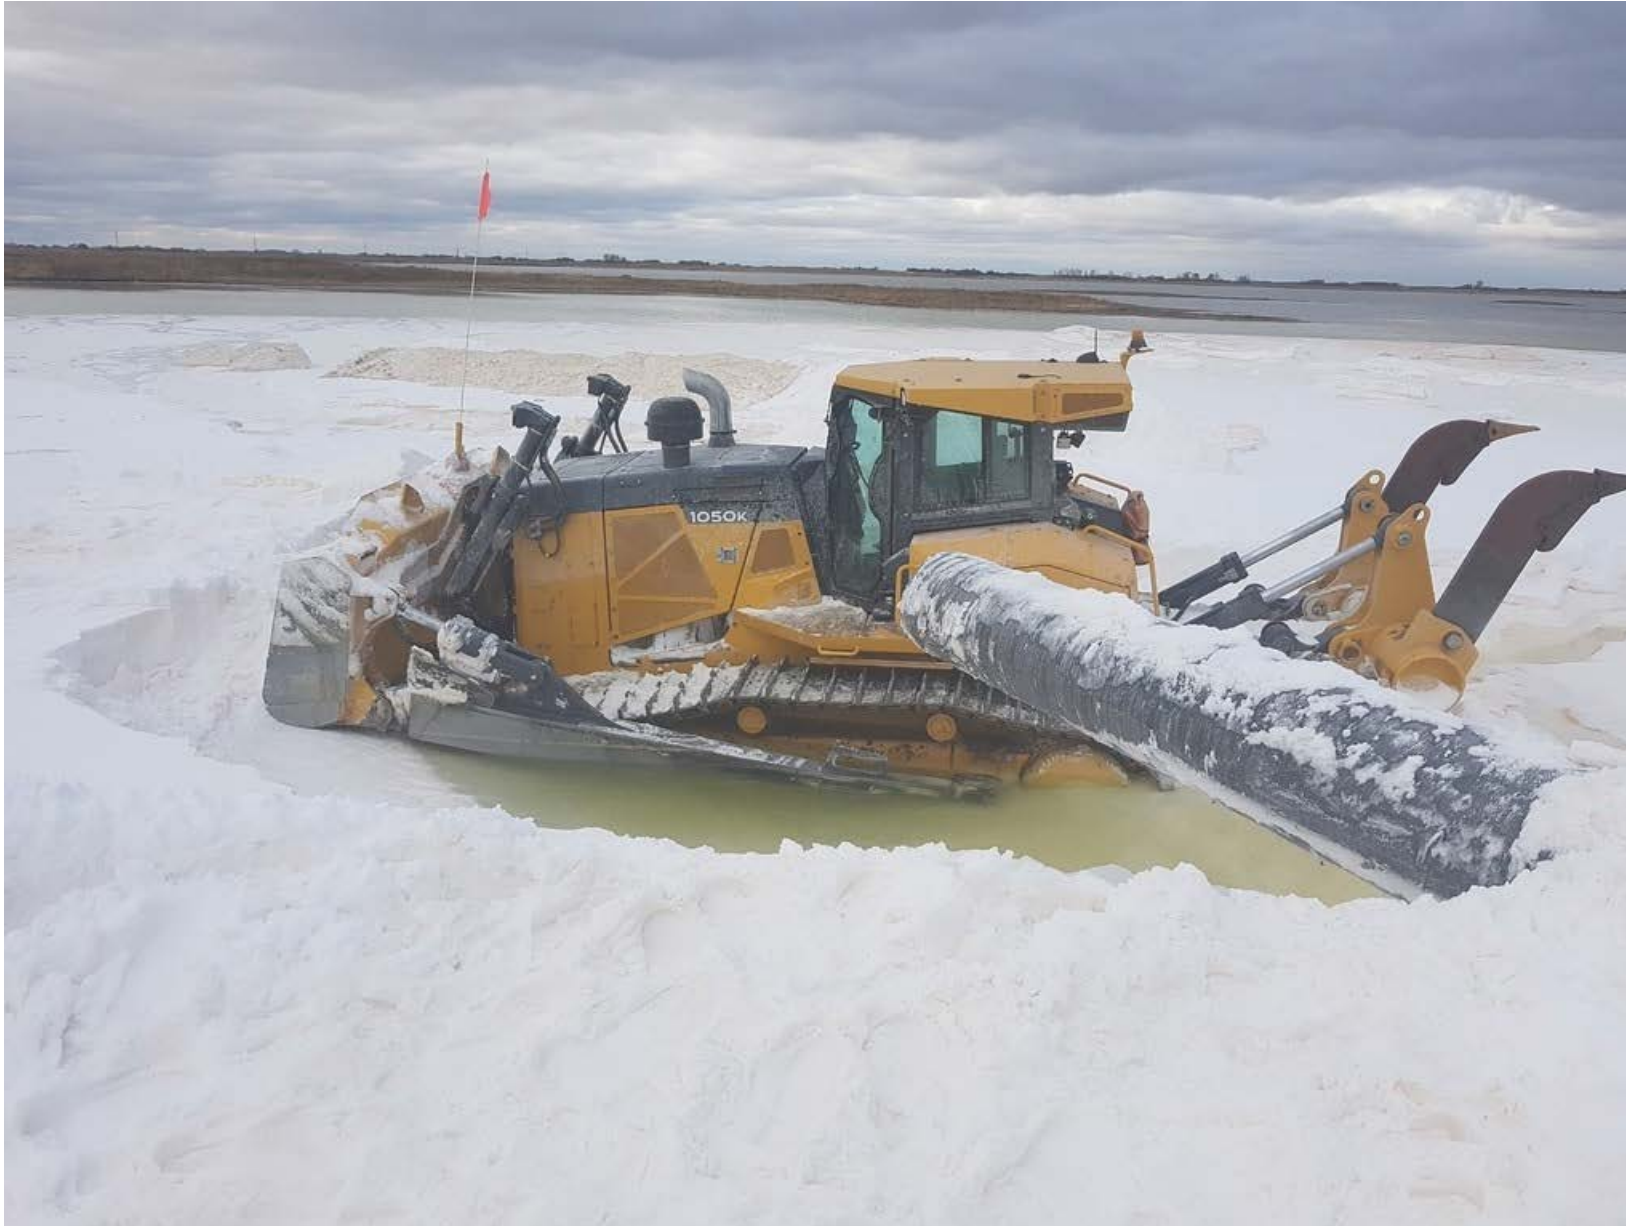
Tailings Pile Dozer Incident – The Result – Oct 2017

Dozer prior to recovery efforts

Significant repair costs and dozer out of service for 6 weeks.
