Managing the risk of 120v electric shock – Outcomes from recent electric shock events

Ben Stevenson, Superintendent Shaft Delivery Robin Butler, Principal Electrical Engineer

Electric shock events in the Jansen shafts

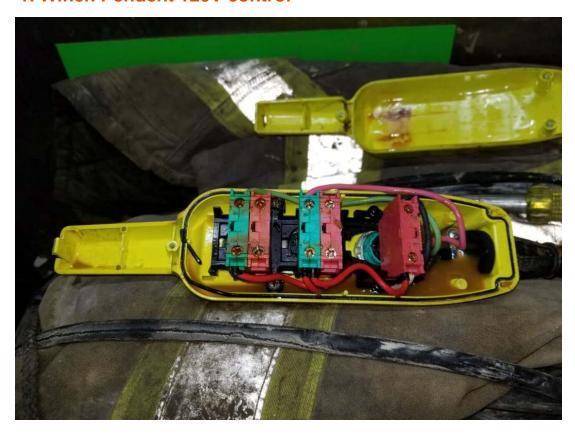
1. Winch Pendent 120V control

1. Electric winch shock – equipment not suited to environment

- No ground provision
- Systems not reviewed for potential hazards in wet conditions
- Equipment design and selection did not consider all potential operating conditions

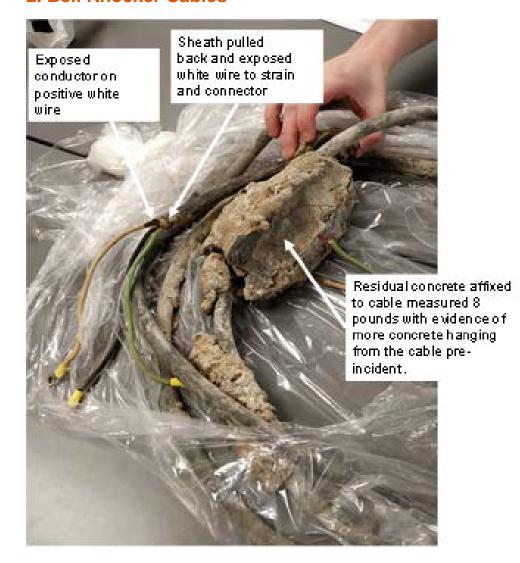
2. Bell Knocker Cables

2. Bell system shock

- Material buildup pulled the cable sheath back, exposing conductor
- Change Management that occurred did not include a review of Electrical Inspections and Controls
- Frequent human interaction = frequent exposure to hazard

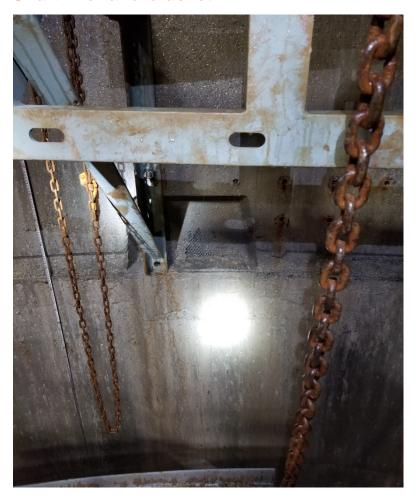
Shaft liner and bracket

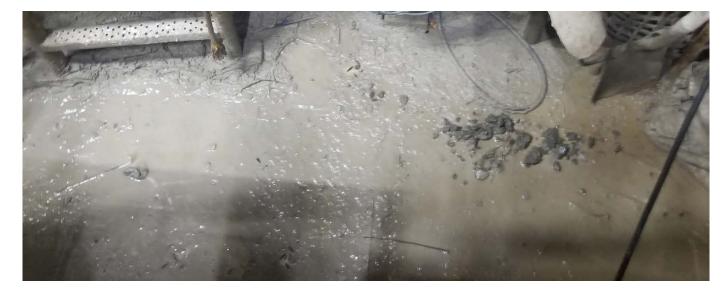
Floor of Shaft Boring Roadheader (SBR)
