Cable Strike Awareness & Elimination

Mosaic Potash - Esterhazy K1 Mine

PBU Cable Strike Team

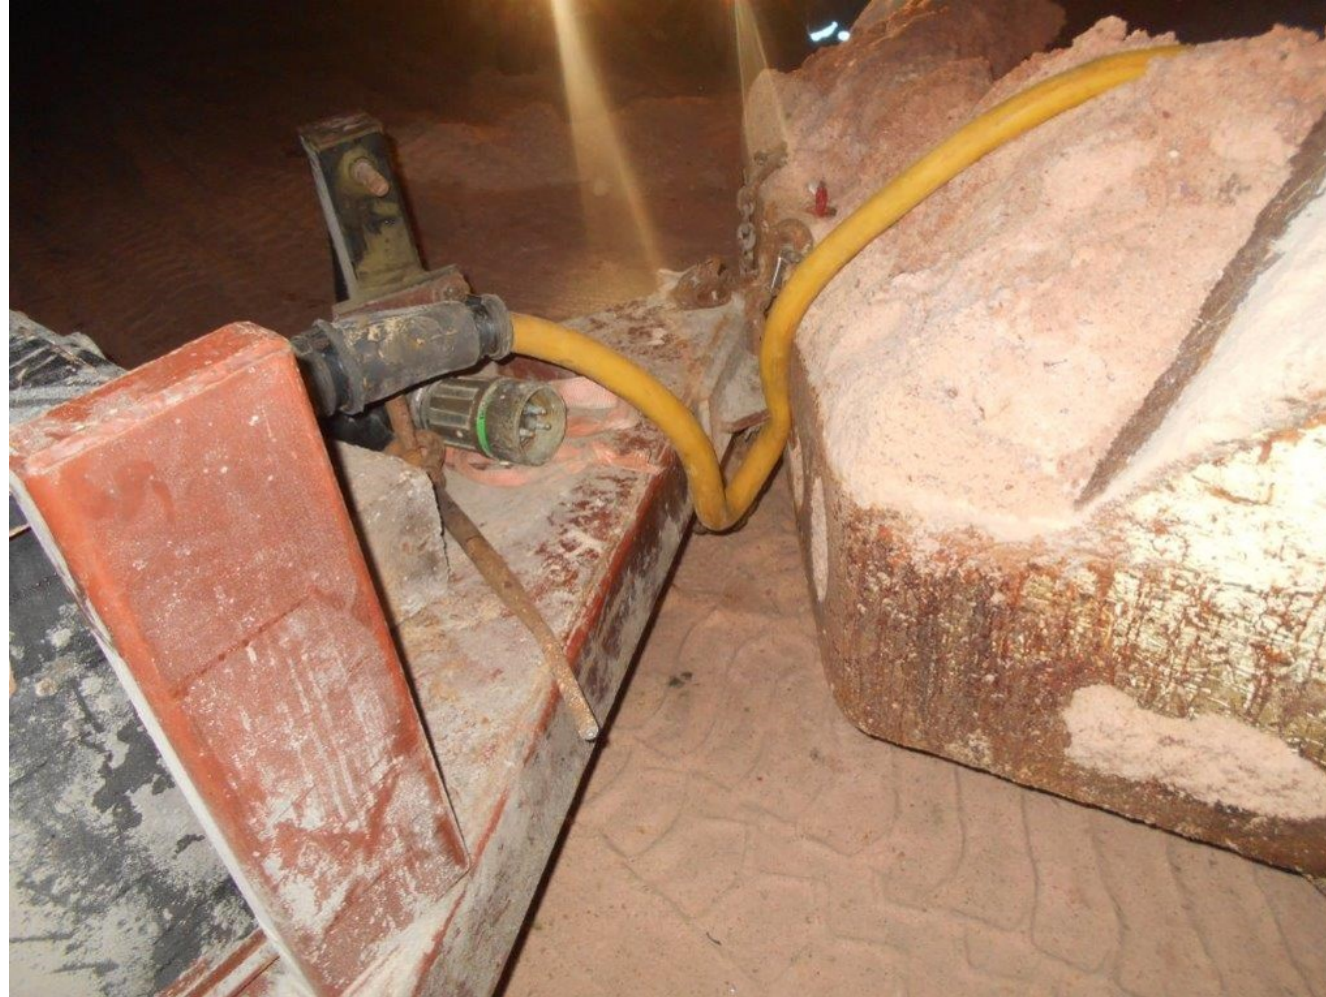
2017 K-1 Mine Cable Strikes

- **January 11, 2017** - Corrective Action: OHC investigated. Administration Control – reviewed SOP with Crews.
- **January 16, 2017** - Corrective Action: OHC investigated. Tool box discussion with each of the crews - cable placement and awareness.
- **March 24, 2017** –Corrective Action: OHC investigated.
- **April 3, 2017** - Corrective Action: OHC investigated. Discussion on situational awareness.
- **April 19, 2017** - Corrective Action: OHC investigated.
- **May 3, 2017** – Corrective Action: OHC investigated.
- **May 2017 - K1 Mine Management had a refocus on cable strikes and set a new course of action.**
- **September 22, 2017** –The 4160 cable had been misplaced along a belt and the belt was rubbing the jacket of the cable until it wore thru the jacket.

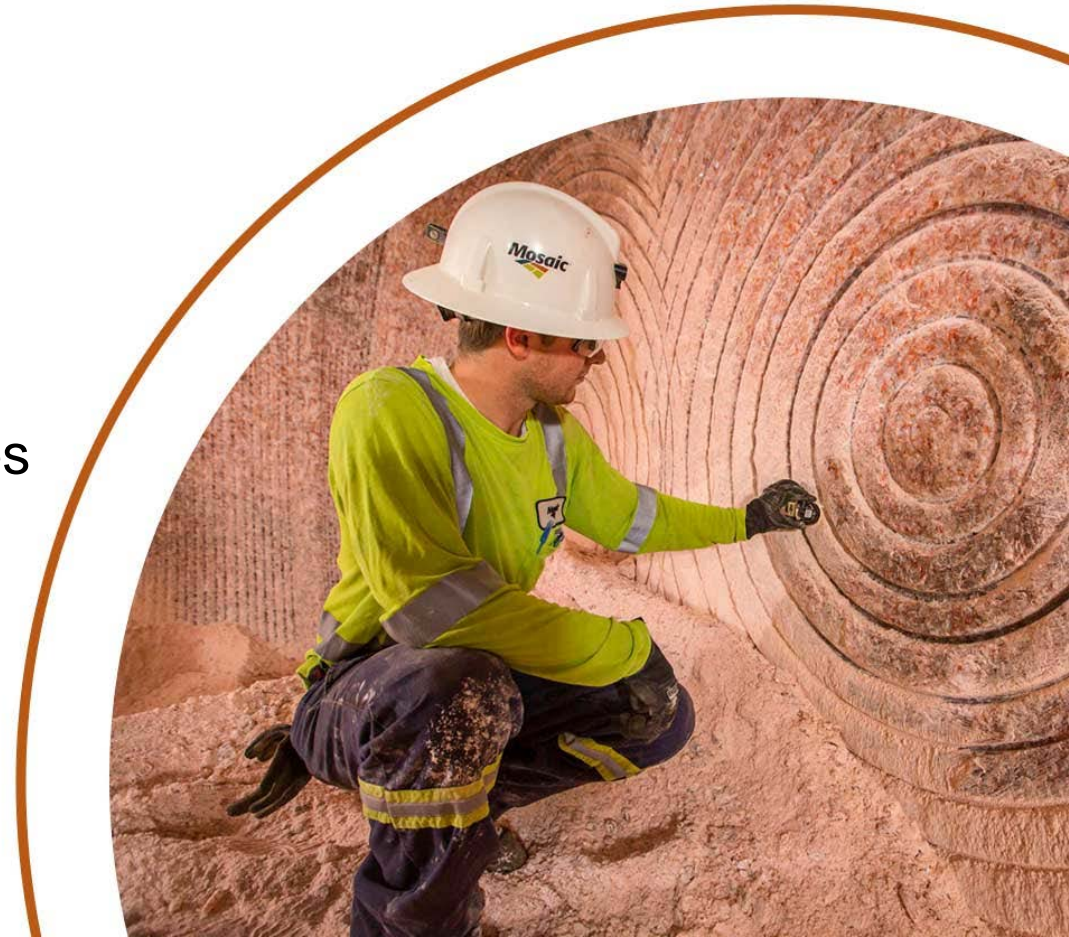
- Reviewed progress & awareness at Spring & Fall Town Halls & Safety Stand Ups
- Front line supervisor spot check goals
- F.L.H.A.s
- Hazard recognition
- Stop observations
- SOPs created:
 - Two rotor cable whip tie off
 - Two rotor cable tie off behind miner
 - Cable tray extensions on side pass bridges
 - Four rotor standard tie off on side pass bridges
- Continuous improvement implementations:
 - Two rotor cable step
 - Two rotor cable skid redesign
- All DOs are reviewed at toolbox meetings
