SASKATCHEWAN MINING ASSOCIATION

October 18, 2018

OBED MOUNTAIN MINE 2013 MINE WASTEWATER RELEASE

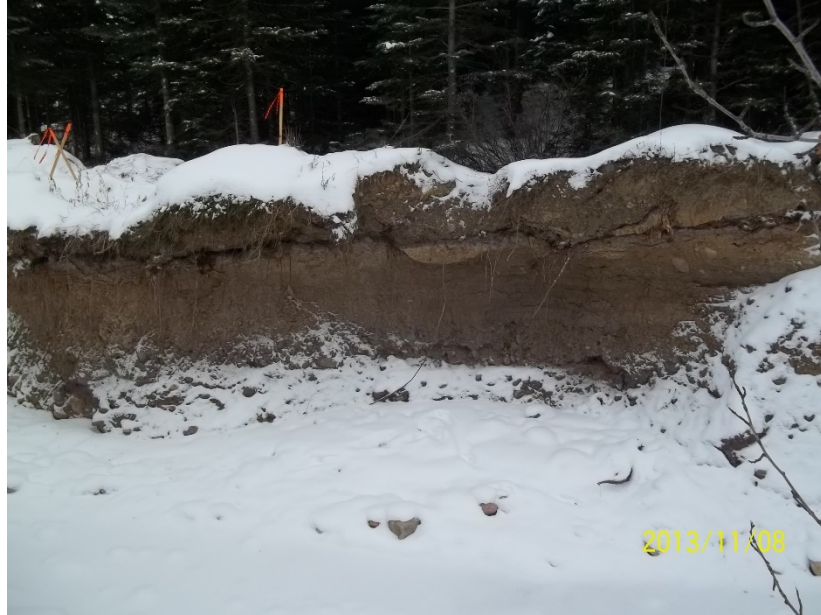
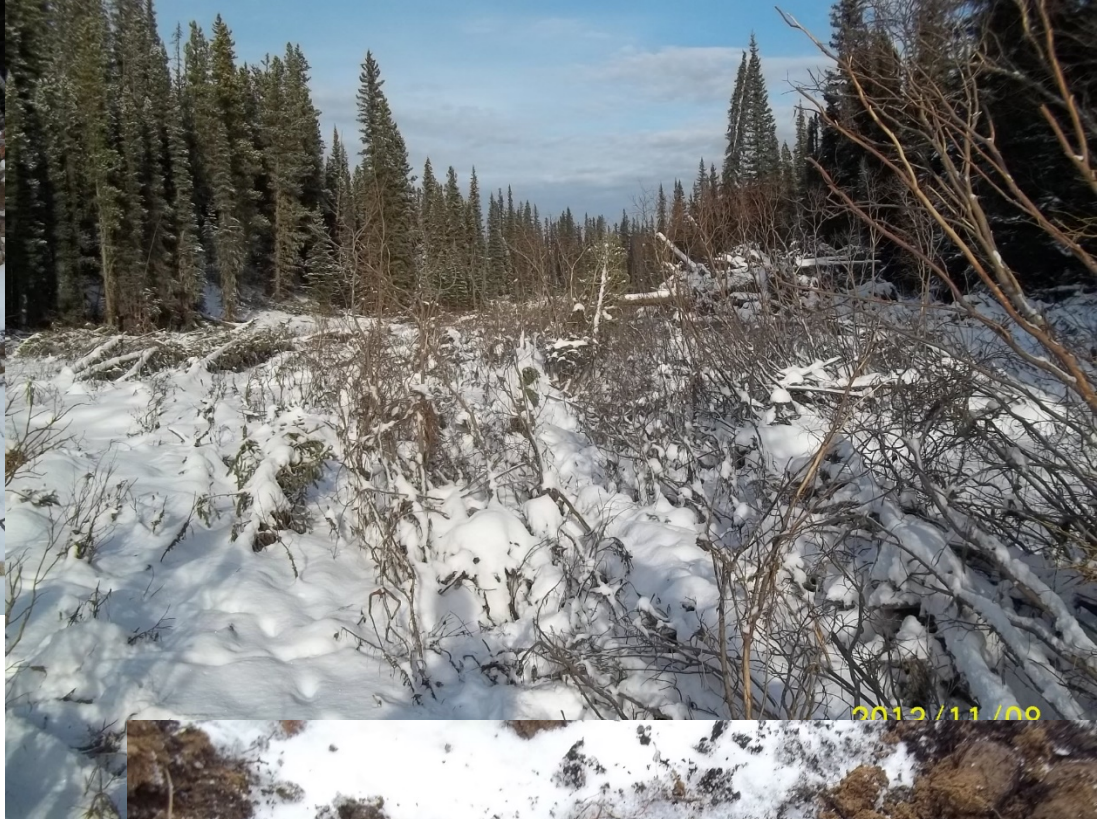
INITIAL ASSESSMENT NOVEMBER 2013

- SUBSTANTIAL EROSION OF STREAM BANK MATERIALS
- DISTURBANCE TO MATURE BLACK SPRUCE VEGETATION COMMUNITY
- DEPOSITION OF RELEASED MATERIAL

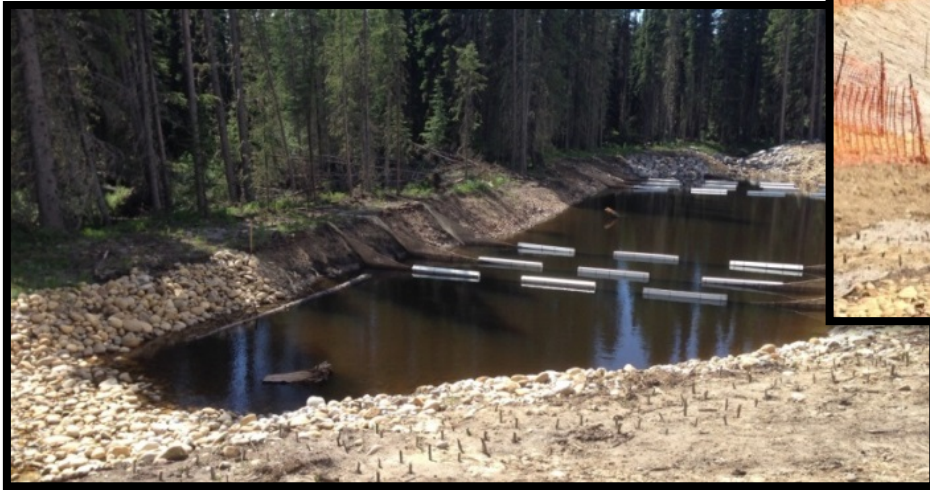
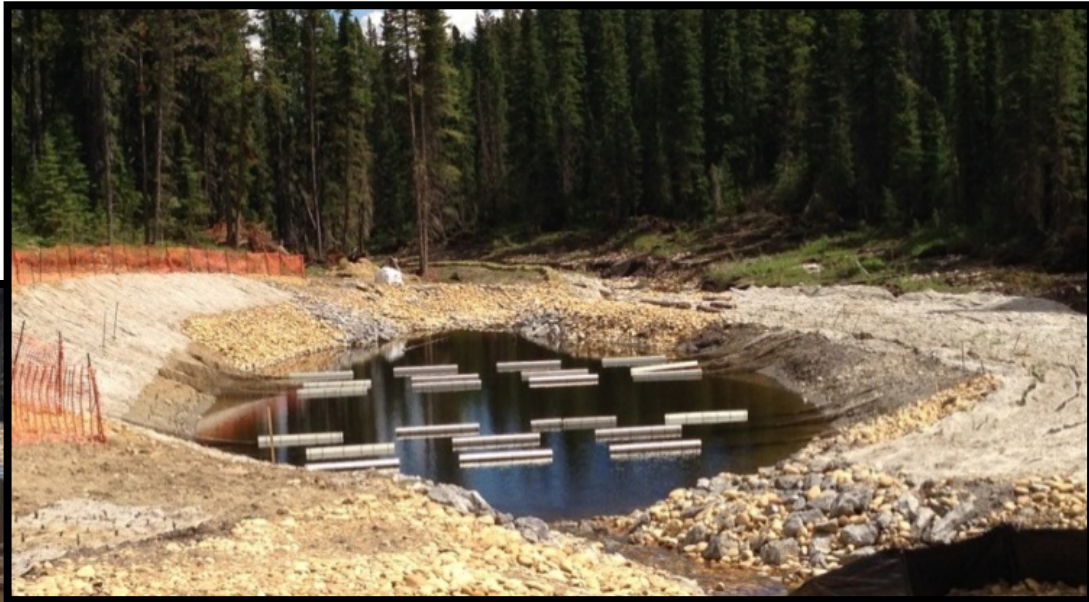
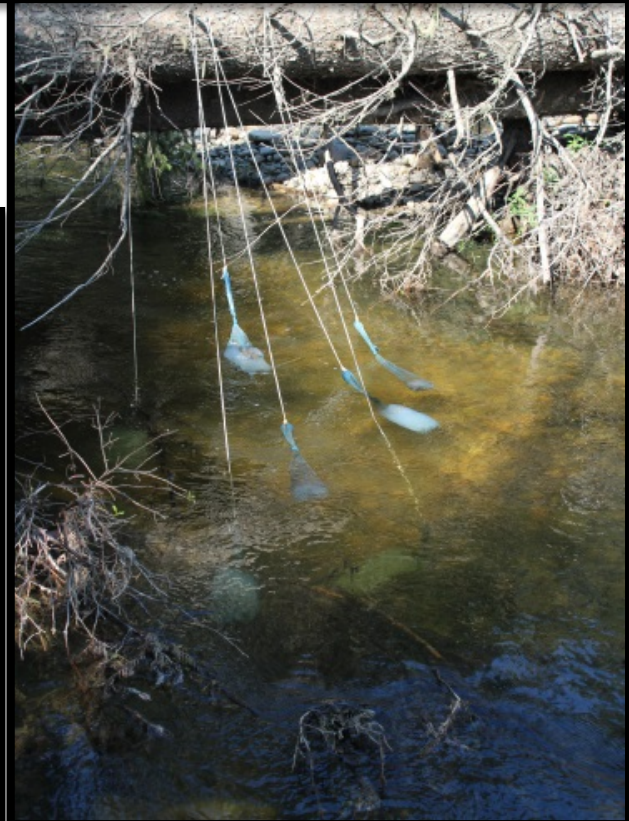
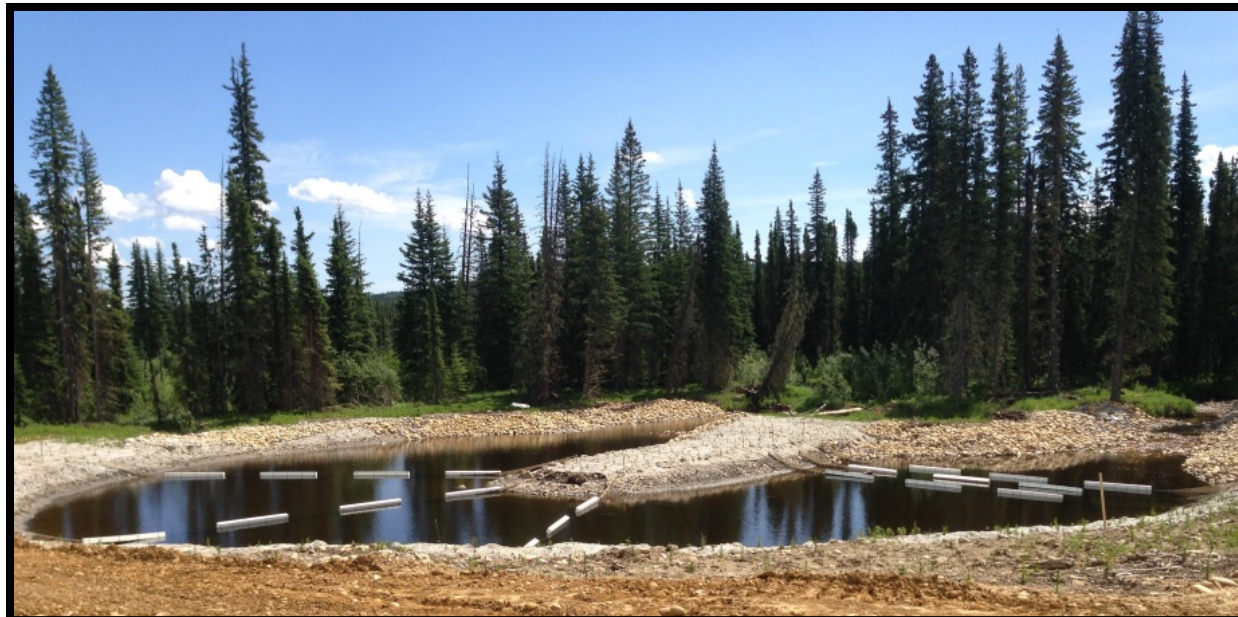
Trap Construction

- Four small settling ponds were constructed on Apetowun Creek
- Fish passage was required on all of the traps
- All weather access provided for maintenance activities
- Full flow through on ST1 and ST2 while ST3 was a partial flow through (flows greater than 0.3 m³/sec entered the trap)
- Enhanced performance with treated jute curtains and anionic floc blocks
