Dozer in the Water January 21, 2017 Estevan Mine

# **January 21, 2017**

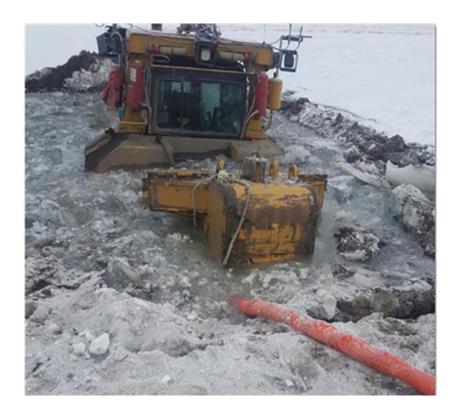
**Incident Happens**

At approx.12:10 am Dozer pushed 1.5 times past the lines shown on GPS screen.

The Dozer came to a stop on a frozen pocket of water, the dozer operator was not aware that he had stopped on the ice over the water.

When the dozer operator proceeded to backup off the body of water the dozer broke through the ice landing flat on both tracks in approx. 2 meters of water. The operator was able to exit the dozer onto land.
